# **SOUTH CREEK BANK MANAGEMENT PLAN**

**Report Prepared for**  
Warringah Council

4 February 2008  
LJ2434/R2381v3

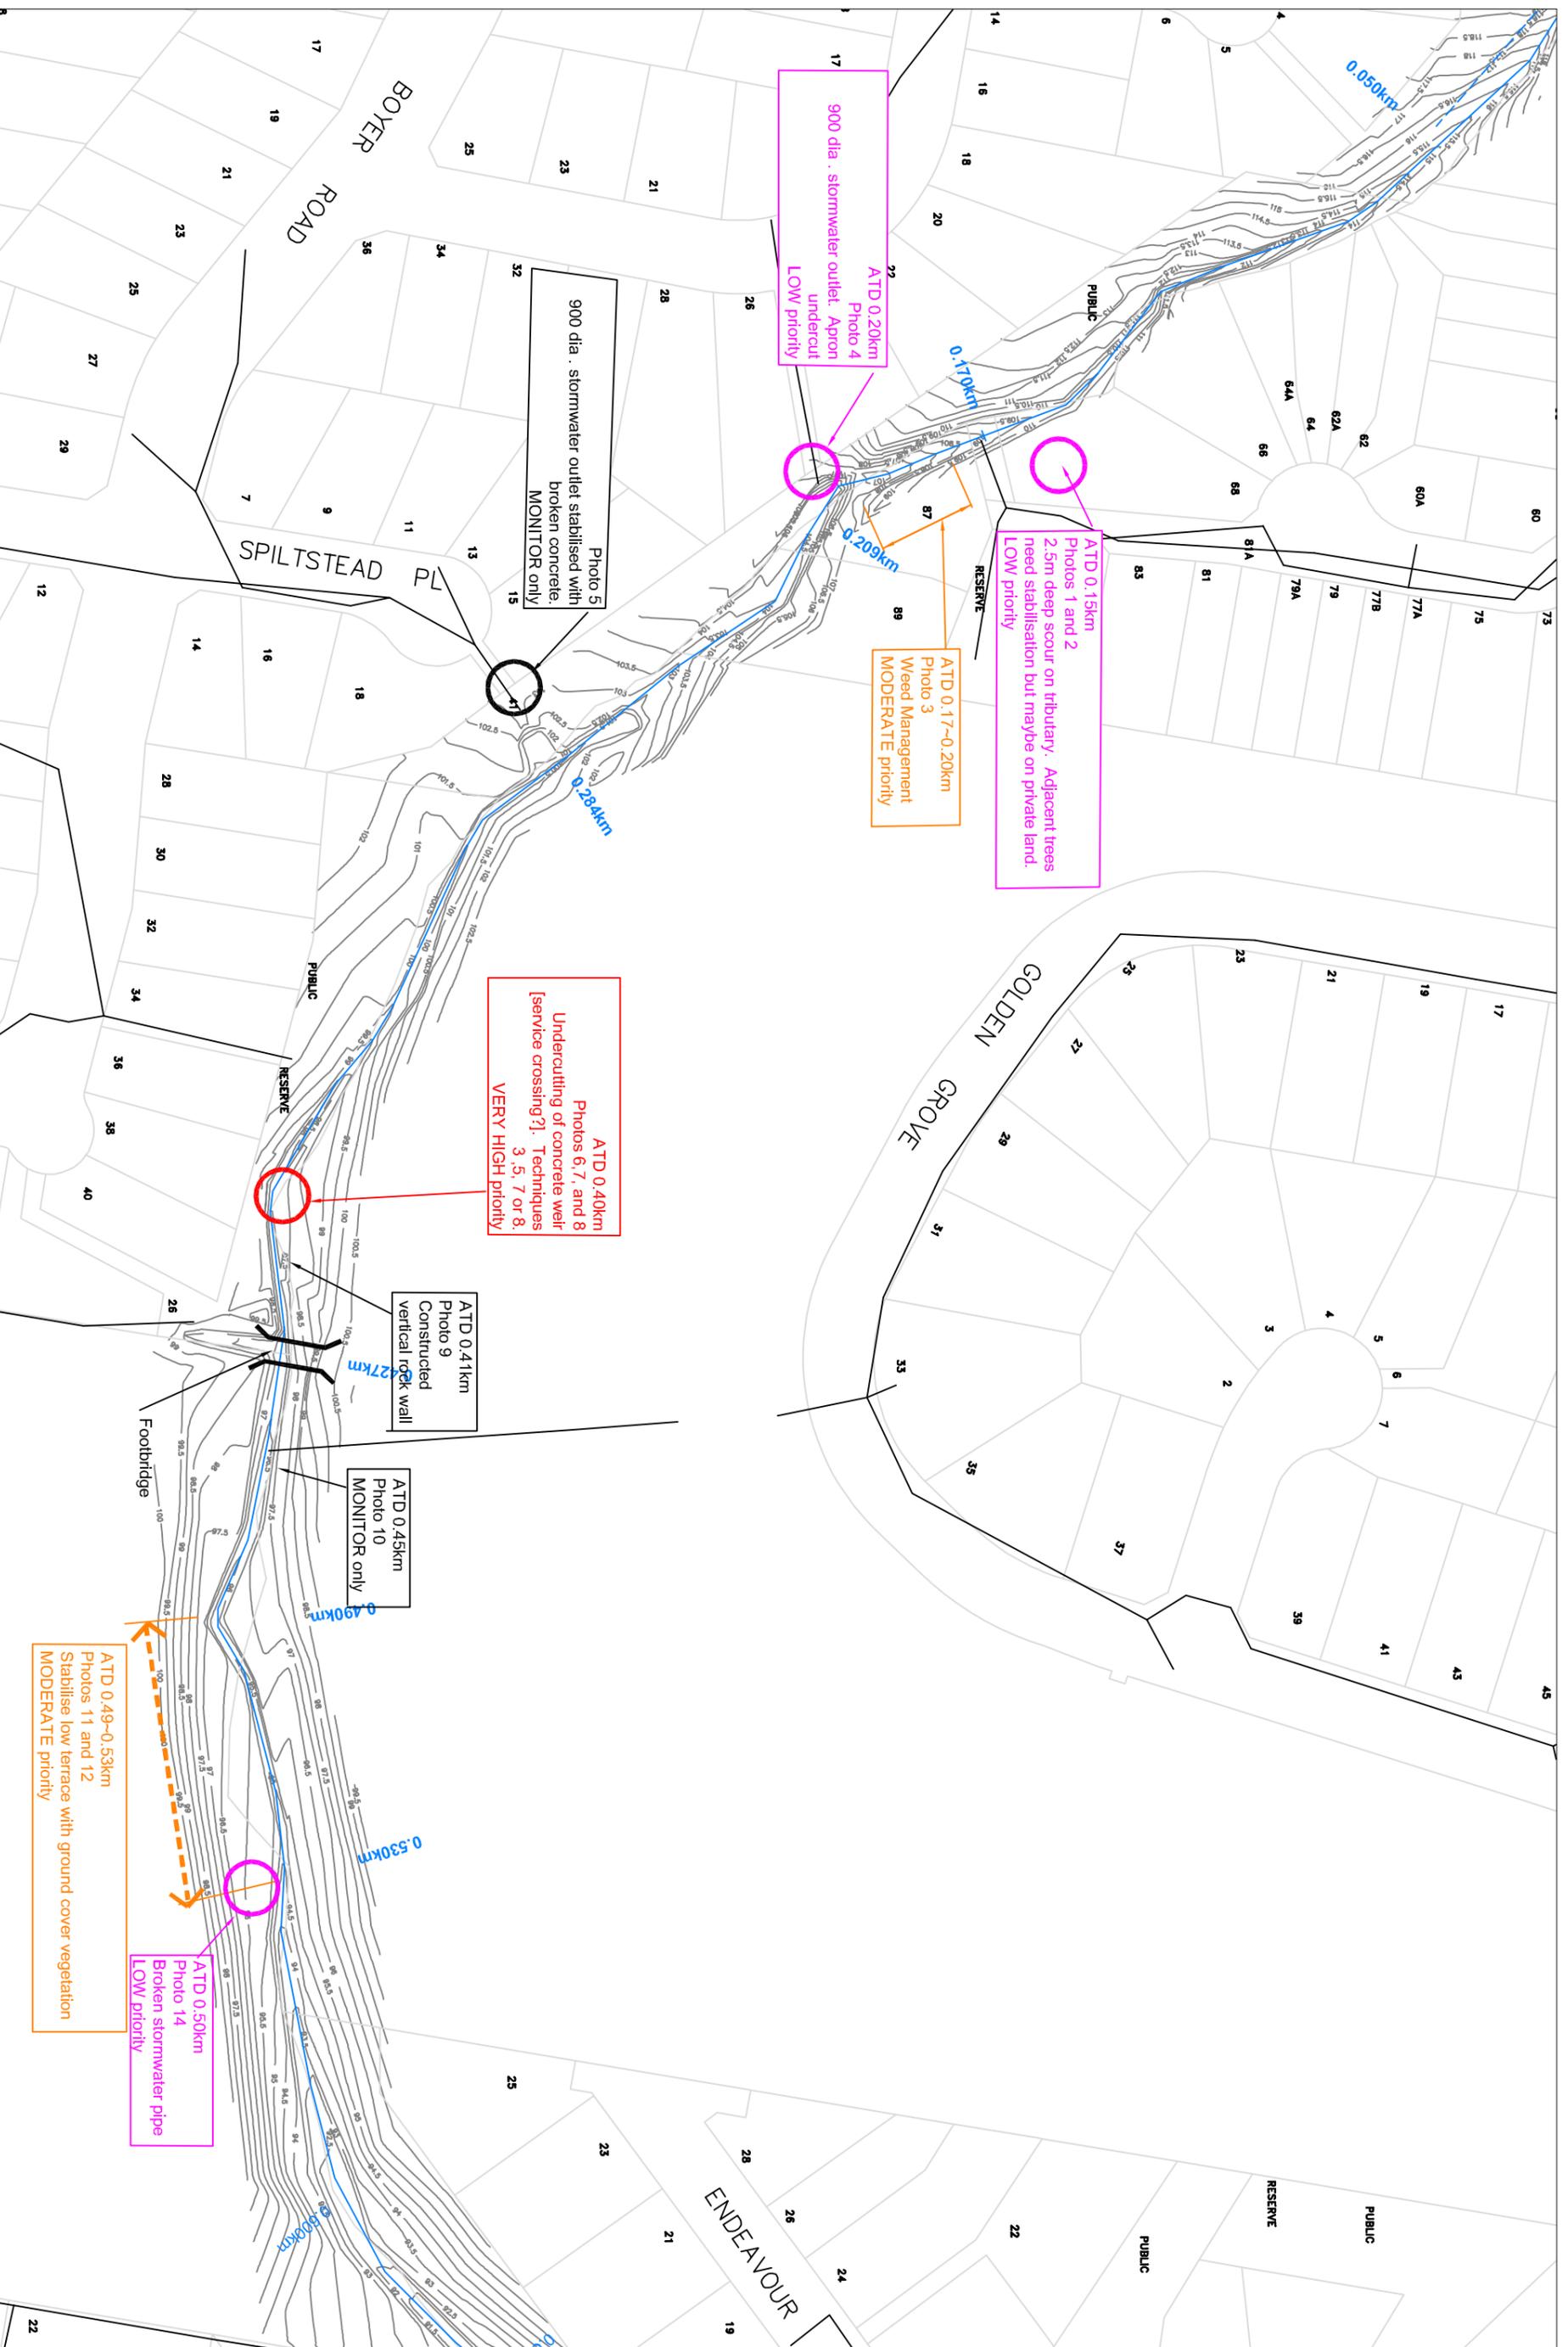
ATD 0.20km  
 Photo 4  
 900 dia. stormwater outlet. Apron undercut  
 LOW priority

ATD 0.50km  
 Photo 14  
 Broken stormwater pipe  
 LOW priority

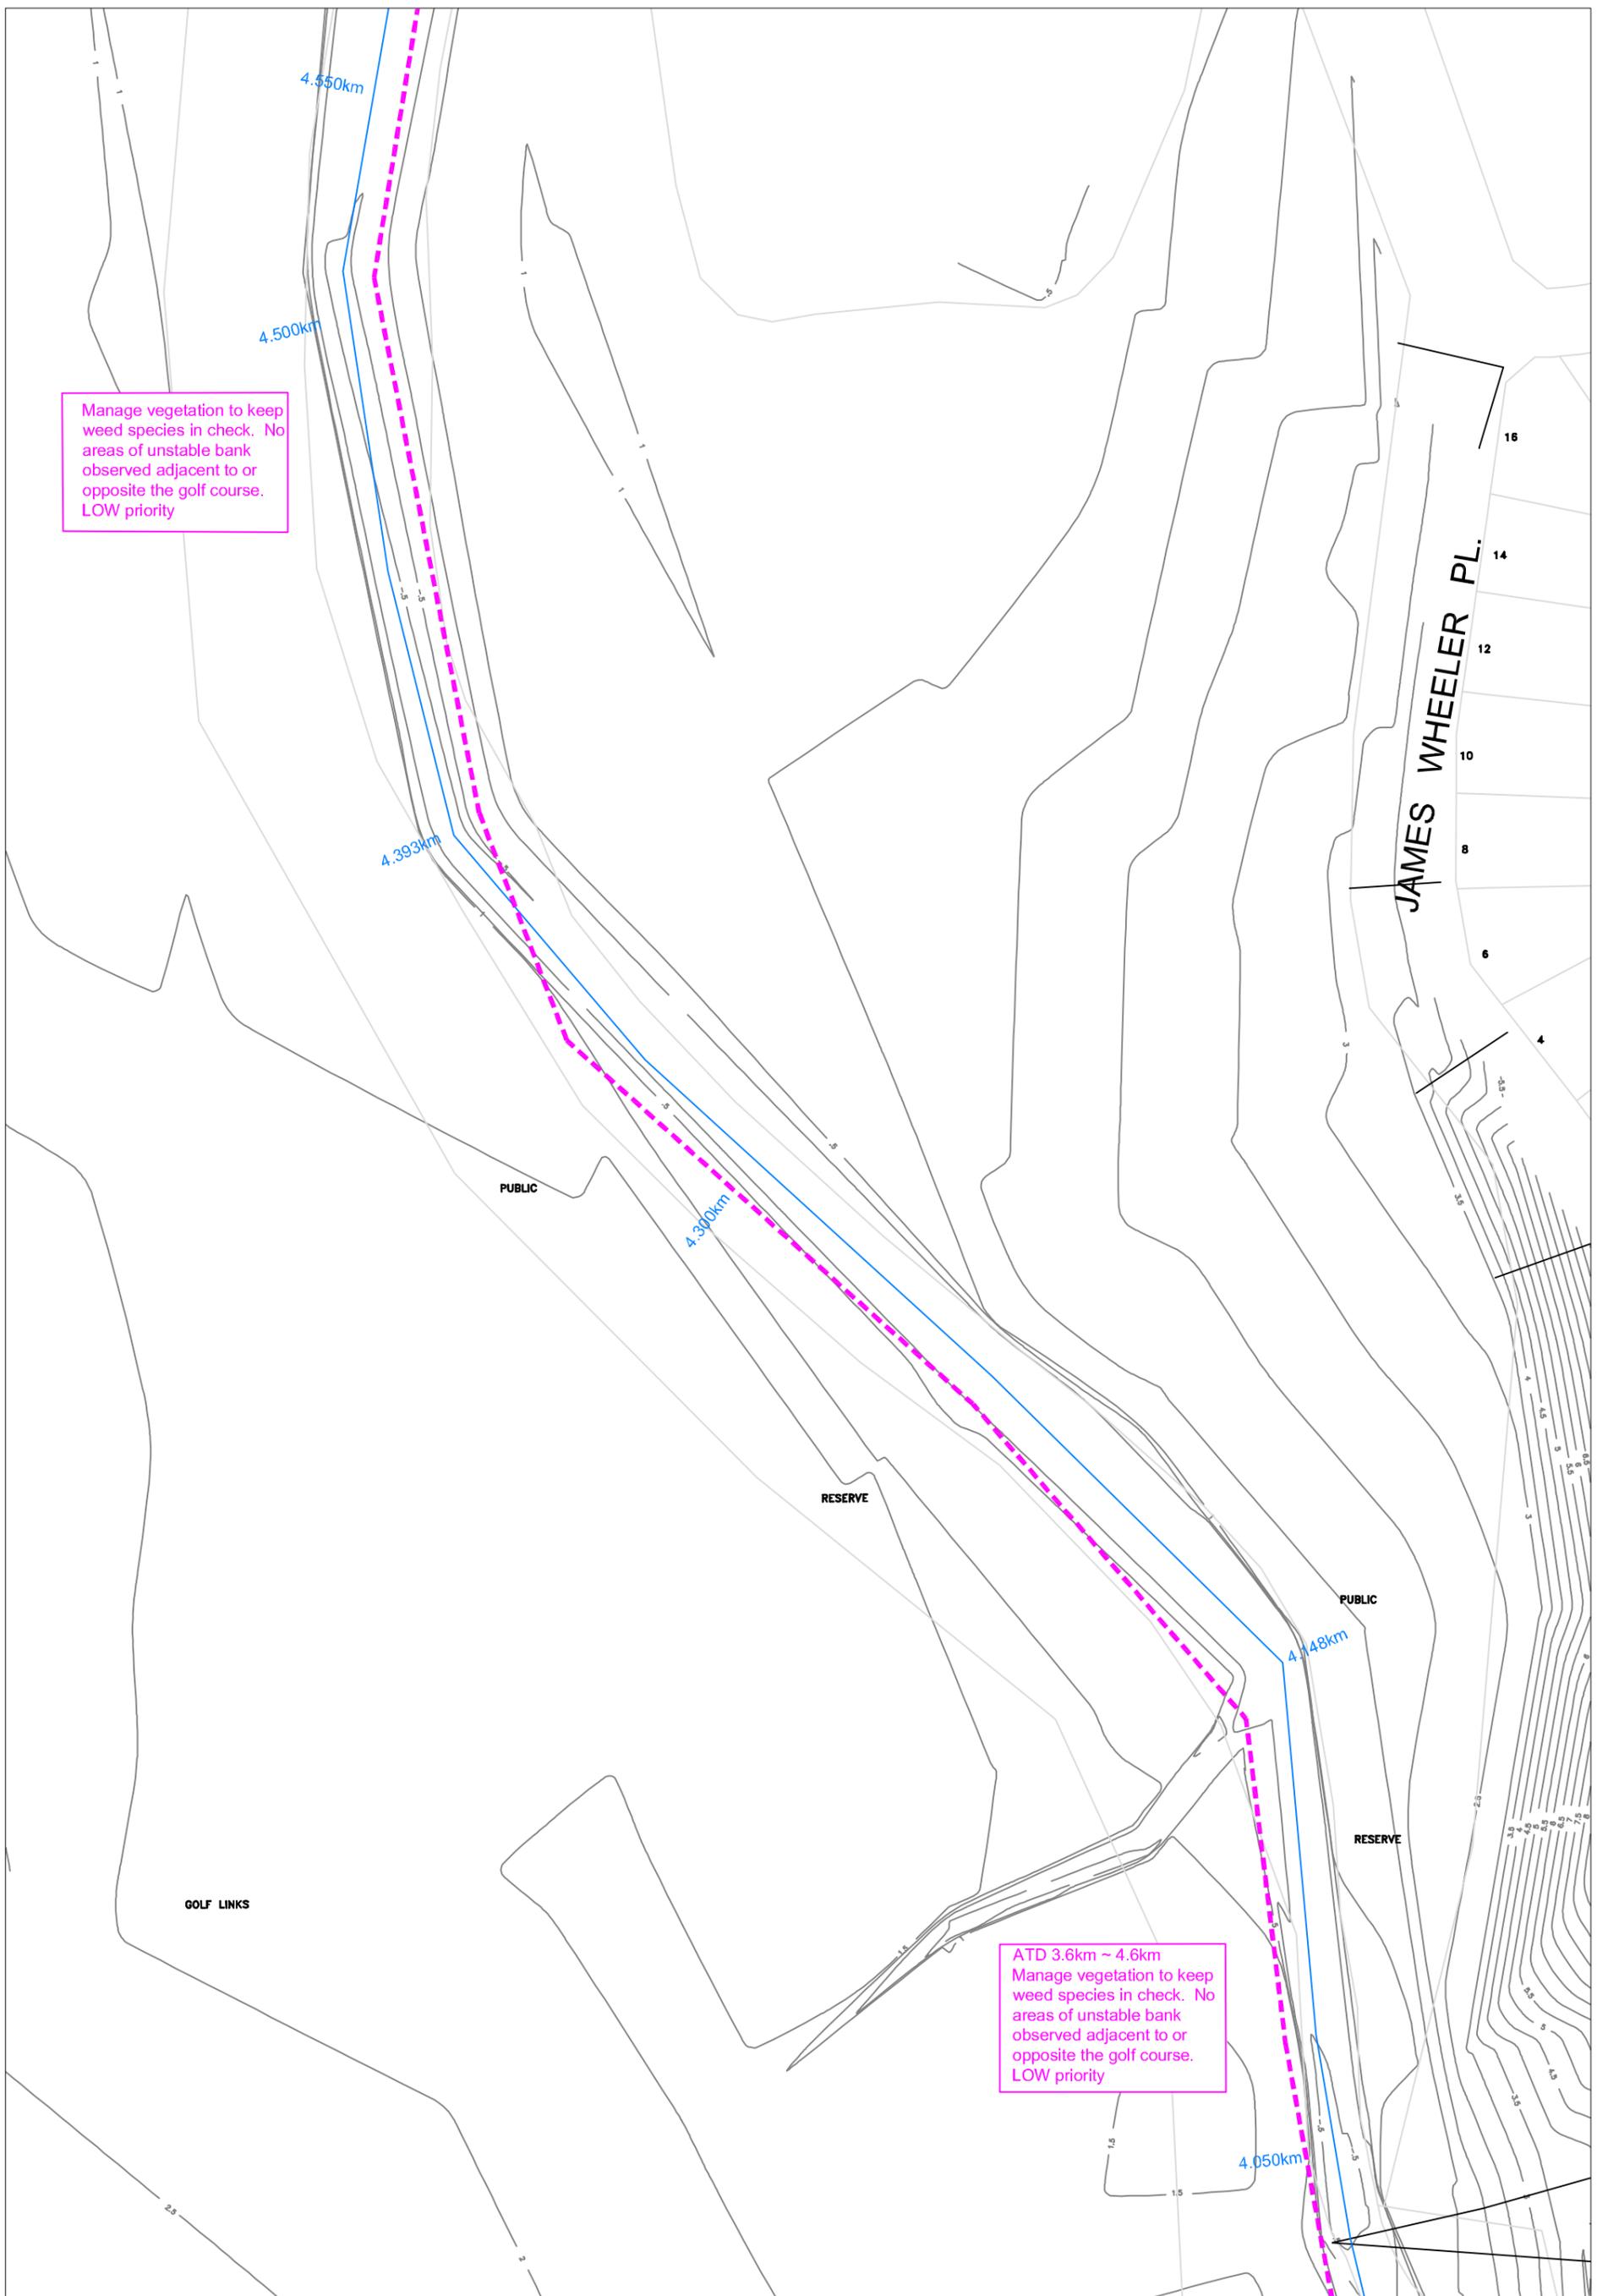
Manage vegetation to keep weed species in check. No areas of unstable bank observed adjacent to or opposite the golf course. LOW priority

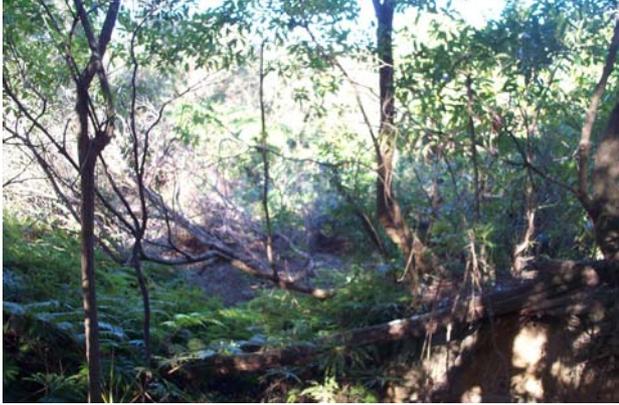
<p><b>Photo 1</b> Looking upstream and across Ref #0049</p>	<p><b>ATD 0.170km</b></p> <p>Left tributary from Brooker Ave, 2.5m deep scour bowl possibly initiated by loss of tree. Refer also photos #50. Machinery access difficult.</p> <p>Tree requires support. Peg observed. Scour maybe in private property but is not affecting buildings.</p>	<p>Management Priority: <b>Low</b> Stabilise tree with rock and soil backfill. Applicable techniques: 4, 5, 6.</p>

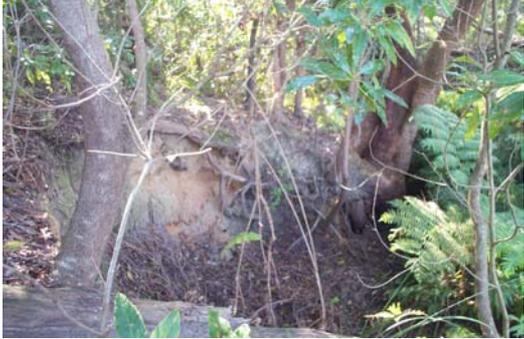
<p><b>Photo 2</b> Looking upstream and across Ref #0050</p>		<p><b>ATD 0.185km</b></p> <p>No stabilisation works required except following weed removal.</p> <p>Management Priority <b>Moderate</b></p> <p>Monitor and weed management.</p>

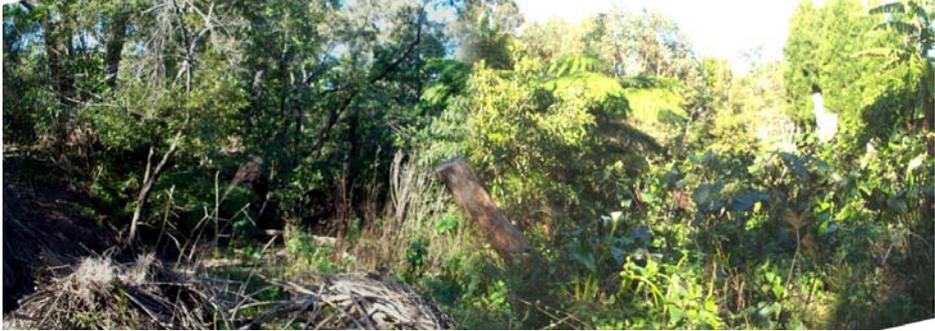
<p><b>Photo 3</b> Looking downstream. Confluence area of left and right tributaries. Right tributary: sandy banks / pocket floodplains Both left and right tributaries inaccessible along creek reserve. Ref #0052 &amp; #0051</p>		<p>Management Priority <b>Very Low</b> Monitor only. If increased undercutting observed repair with un-grouted rock spalls or confinement mat backfilled with cobbles. Technique ?</p>

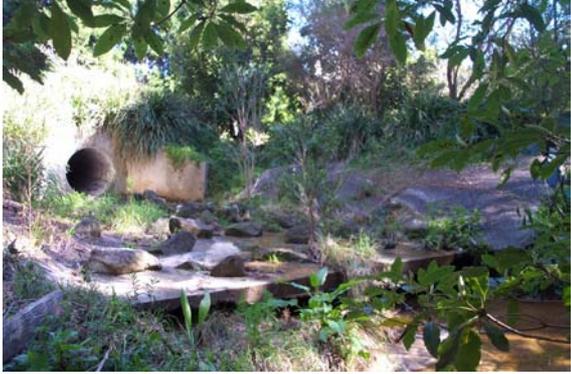
<p><b>Photo 4</b> Looking upstream and across Ref #0048</p>	<p><b>ATD 0.209 km</b></p> <p>900dia. RCP SW outlet. Concrete apron with embedded rock spalls. Apron undercut. Concrete on banks downstream of headwall. Creek appears to be stable in this reach.</p>	<p>Management Priority <b>Very Low</b> Monitor only. If increased undercutting observed repair with un-grouted rock spalls or confinement mat backfilled with cobbles. Technique ?</p>

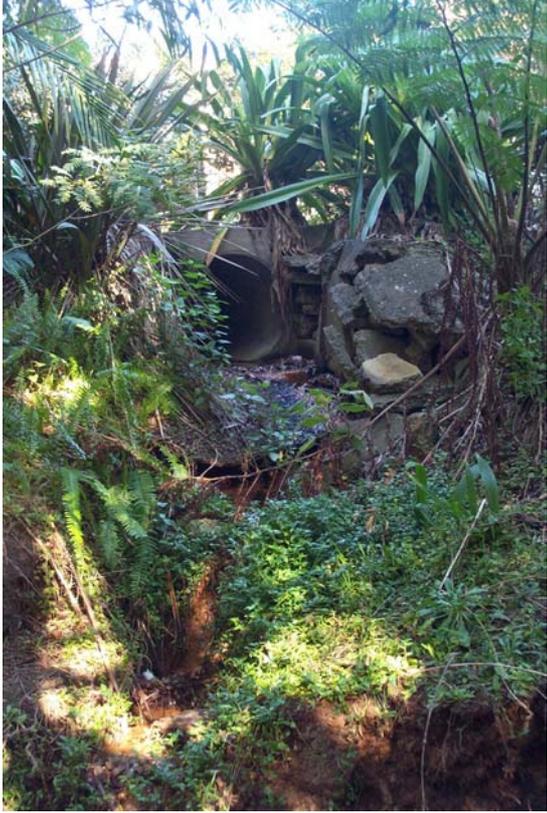
<p><b>Photo 5</b> Looking upstream and across Ref #0047</p>	<p><b>ATD 0.284 km</b></p> <p>900dia RCP SW outlet. Broken concrete used for wingwall.</p> <p>Outlet appears to be stable but is unsightly. Rock armouring in lieu of broken concrete would be preferred.</p>	<p>Management Priority <b>Very Low</b></p> <p>Monitor only.</p>

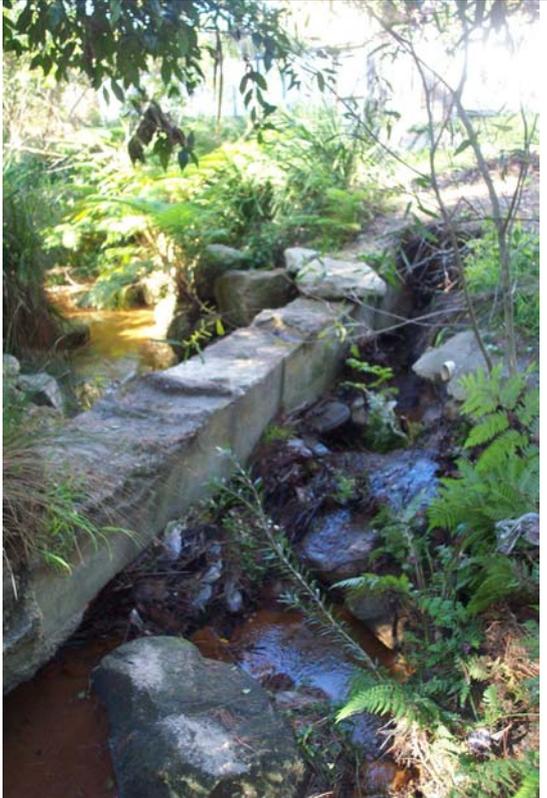
<p><b>Photo 6</b> Looking upstream Ref #0044</p>	<p><b>ATD 0.300 km</b></p> <p>Placed rock boulders on right bank downstream of concrete weir [protecting a service crossing?]. Low flow passes under weir. Scour hole on right bank upstream of weir Weir/bank undercut on left bank for approx. 15m. Likely to eventually cause failure/cracking of weir.</p> <p>Vegetation includes: Bracken on left bank Young castor oil tree Palms Conifer [sp?]</p> <p>Small waterfall ≈30m upstream of weir.</p>	<p>Management Priority <b>Very High</b></p> <p>Stabilisation using rock or equivalent required.</p> <p>Techniques 4, 5, or 6.</p>

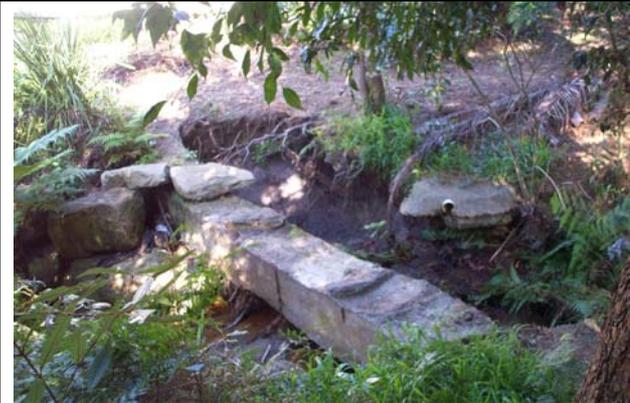
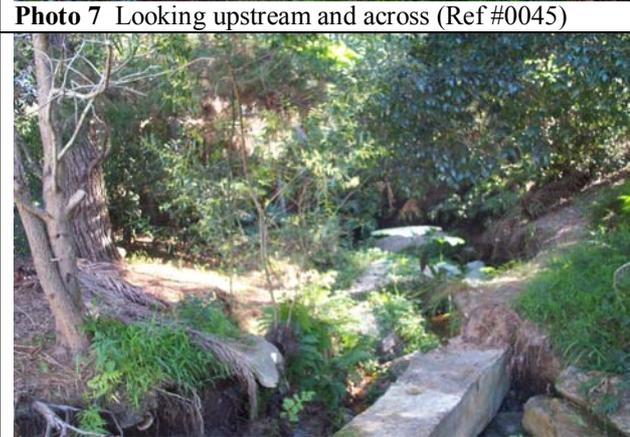
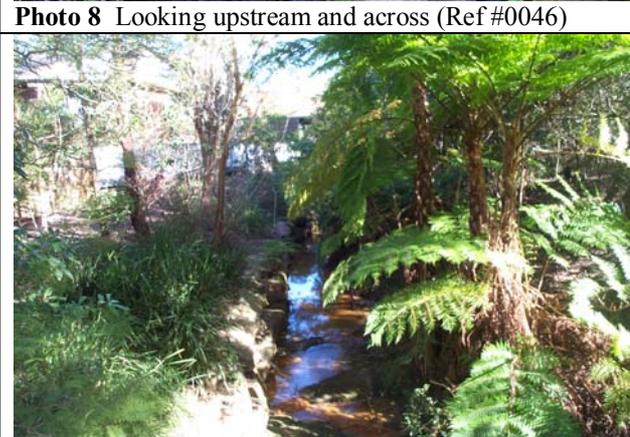
<p><b>ATD 0.427 km</b> Upstream of school / footbridge. Placed rock boulders on right bank extend upstream to concrete weir. Rock wall appears to be stable.</p> <p>Lomandra planted behind rock wall Tree ferns on right bank.</p>	<p>Management Priority <b>Monitor only</b></p> <p>Monitor only for signs of bank instability every 1 to 2 years or after large flood.</p>

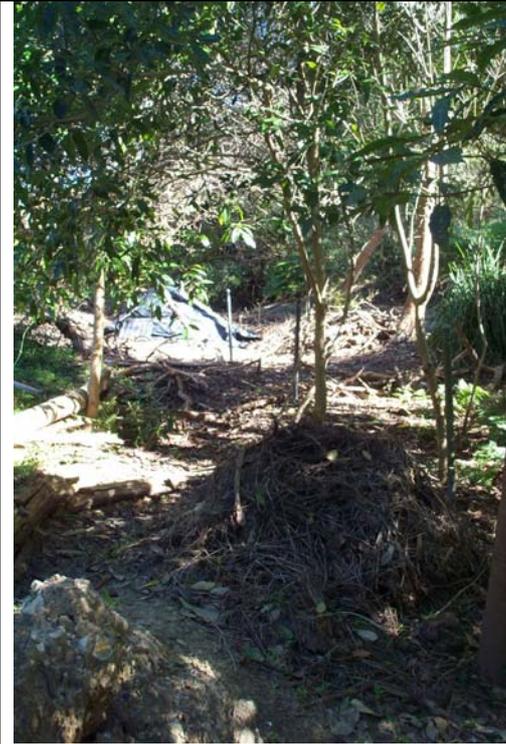
<p><b>ATD 0.490 km</b> Adjacent to school. Plastic covered compost heap. Galv. Steel posts [fence line?]</p> <p>Bank 1.5m High composed of sandy silt.</p> <p>Evidence of frequent access by students resulting in loss of ground cover on Lower terrace. Regeneration of ground cover vegetation needed to stabilise area and reduce sediment loss.</p> <p>Exposed Low vertical bank is vulnerable to erosion.</p>	<p>Management Priority: <b>HIGH</b></p> <p>Re-vegetate banks/Lower terrace using shade tolerant species. Use fencing or other barrier to protect vegetation. Techniques 1,2, 3.</p>

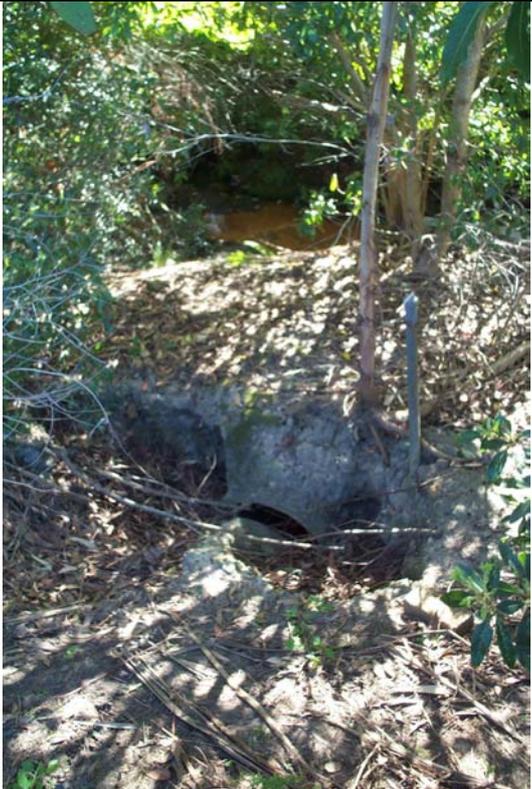
<p><b>Photo 14</b> Broken stormwater pipe from school grounds Ref #0053</p>	<p><b>ATD ≈ 0.530km</b></p> <p>Broken SW pipe on right bank coming from school.</p> <p>Approx. 100m d/s of footbridge.</p> <p>Soil washing into pipe has formed a sink hole but quantity of soil lost does not appear to be large.</p>	<p>Management Priority: <b>Low</b></p> <p>Repair pipe to limit erosion and sediment transport.</p> <p>Responsibility maybe NSW Government – school drain.</p>

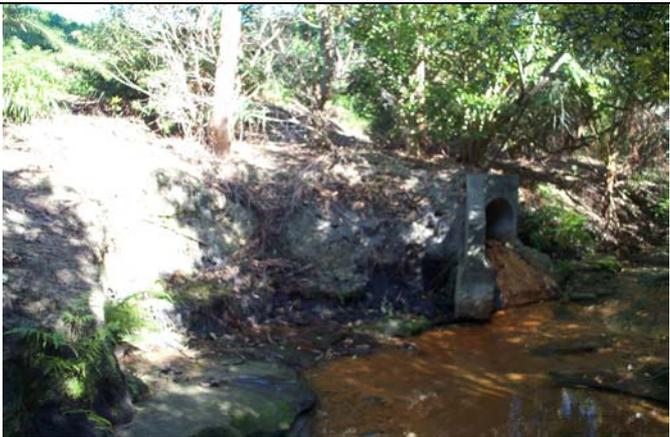
<p><b>Photo 15</b> Looking upstream Ref #0054</p>	<p><b>ATD 0.710km</b></p> <p>SW pipe outlet. Orange-brown discharge coming from pipe. Limited washout of bank behind headwall may lead to future instability of outlet. 2.4m length of RCP aligned with right creek bank 15m d/s of outlet but doesn't appear to be causing problems.</p>	<p>Management Priority: <b>Monitor</b></p> <p>Test and monitor discharge from SW drain.</p> <p>Monitor headwall stability. Use techniques 4, 5 or 6 if future stabilisation is required.</p>

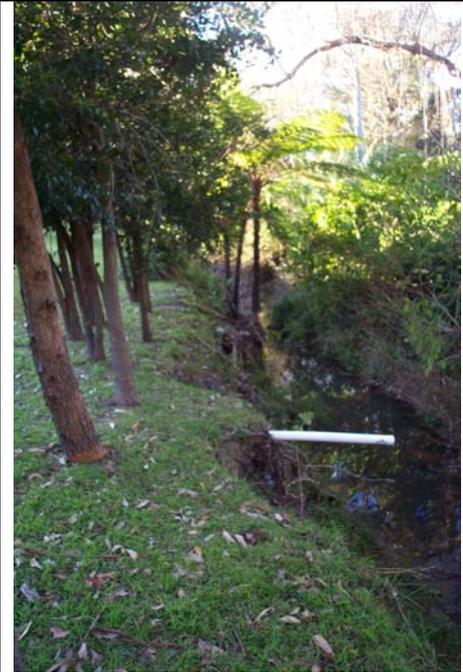
<p><b>ATD 1.870km</b></p> <p>Erosion of left bank likely to be due to runoff and seepage from mown area as well as creek flows.</p> <p>Bank material is silty sand. Improved SW outlets are required for both the UPVC pipe and larger SW drains terminating up to 20m from the creek bank.</p>	<p>Management Priority <b>HIGH</b></p> <p>For left bank: Technique 4 or 5 with bank re-vegetation. Limited opportunity for bank battering due to trees. If tree set back is sufficient use Technique 1 together with 2, 4, or 5. Technique 3 is also applicable.</p> <p>Recommend toe rocks be used on right bank in conjunction with left bank works.</p>
<p><b>Photo 35</b> View downstream behind Willandra Village Ref #0076</p>	<p><b>ATD 1.825 km</b></p> <p>Confluence area. Undercut right bank, tree destabilised. Tributary flow is undercutting bank on outside bend and destabilising tree.</p>	<p>Management Priority <b>URGENT</b></p> <p>Use technique 4 or 5 to stabilise tree and right bank but maintain similar waterway area. May need to lop tree [technique 7].</p>

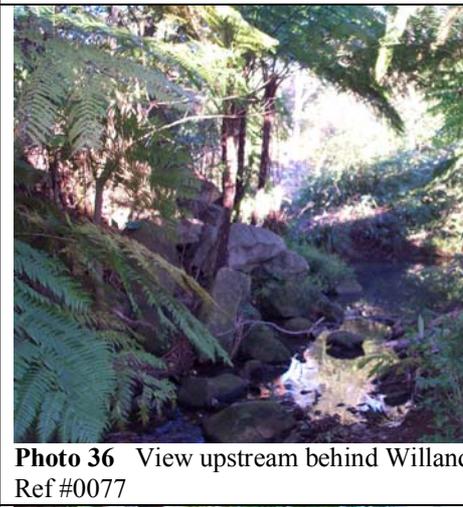
<p><b>ATD 1.825 km</b></p> <p>Confluence area. Undercut right bank.</p> <p>If tree falls further significant scour is likely on both banks due to deflected flows.</p>	<p>Management Priority <b>URGENT</b></p> <p>Refer to above.</p>

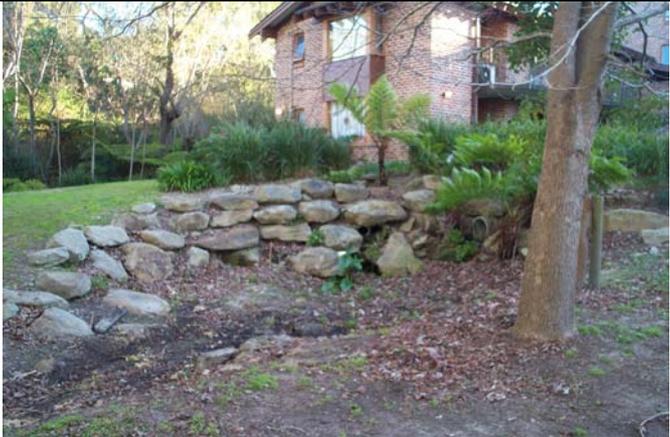
<p><b>ATD 1.837 km</b></p> <p>Willandra Village SW outlet and channel. Outlet channel appears stable but is bare of vegetation. Deep sandy deposits near creek are mobile.</p>	<p>Management Priority <b>MODERATE</b></p> <p>Recommend rock lining or other form of stabilised vegetation to stabilise sandy deposits. Techniques 2 or 11.</p>

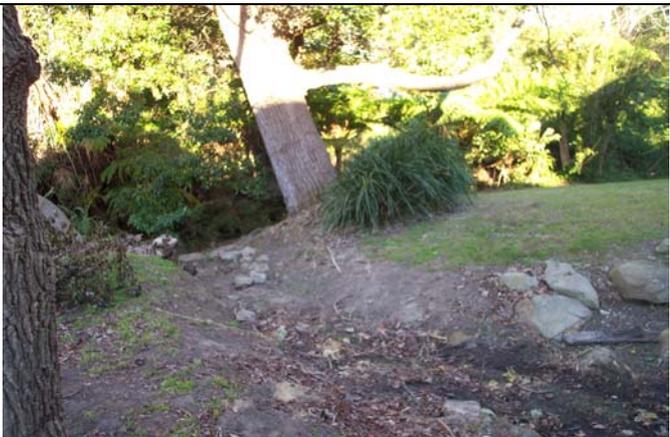
<p><b>ATD 1.837 km</b></p> <p>Willandra Village SW outlet channel to creek.</p>	<p>Management Priority <b>MODERATE</b></p> <p>Refer to comments above.</p>

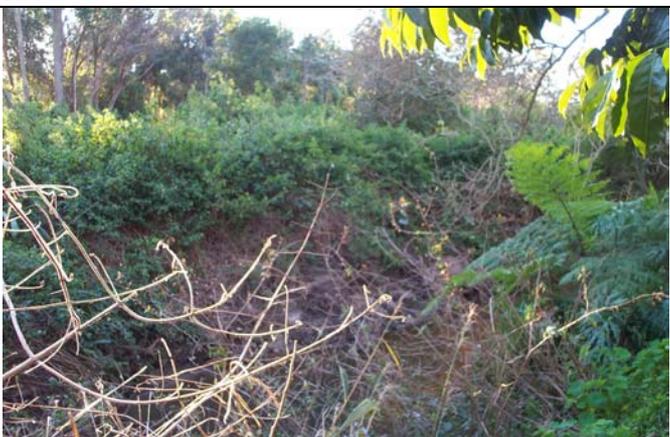
<p><b>ATD 1.98 km</b></p> <p>Reach between Willandra Road and Douglass Place. Typical of conditions where area has been invaded by weed species and frequent patches of bank are exposed.</p>	<p>Management Priority <b>LOW to MODERATE</b></p> <p>Refer to comments above.</p>

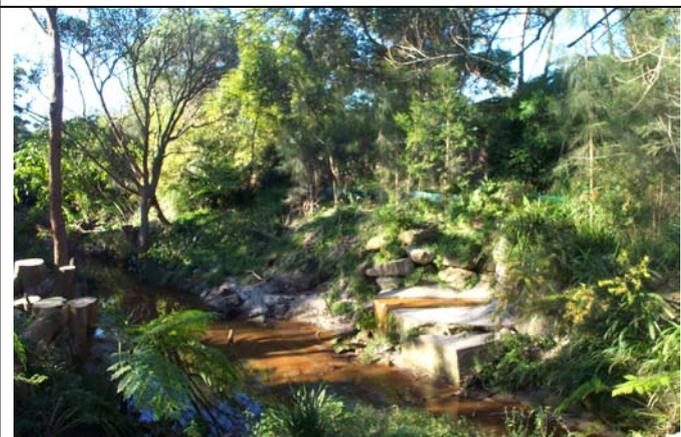
<p><b>ATD 2.267 km</b></p> <p>Broken concrete apron at outlet on right bank.</p> <p>Tree lopped on left bank.</p>	<p>Management Priority <b>LOW</b></p> <p>Monitor only at this stage. Use rock boulders to stabilise bank if scouring occurs.</p>

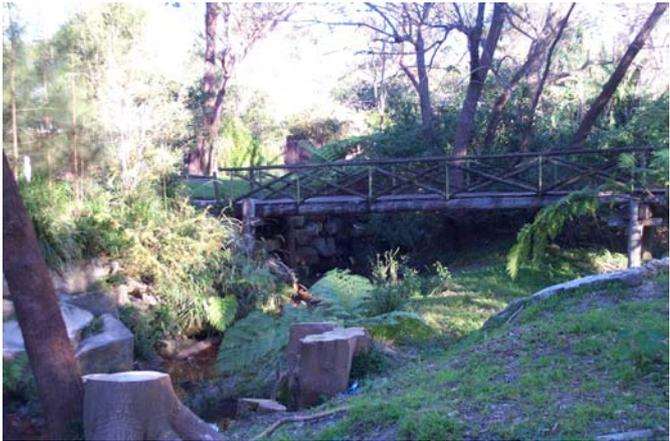
<p><b>Photo 48</b> View upstream towards footbridge [See also photo 47 and 49]. Ref #0089</p>	<p><b>ATD 2.267 km</b></p> <p>Lopped trees. Banks stable. Broken concrete apron at SW outlet on right bank.</p> <p>Evidence of some bush regeneration work.</p>	<p>Management Priority <b>LOW</b></p> <p>Monitor only at this stage. Use rock boulders to stabilise bank if scouring occurs.</p> <p>Staged clearing of weed species. Technique 2.</p>

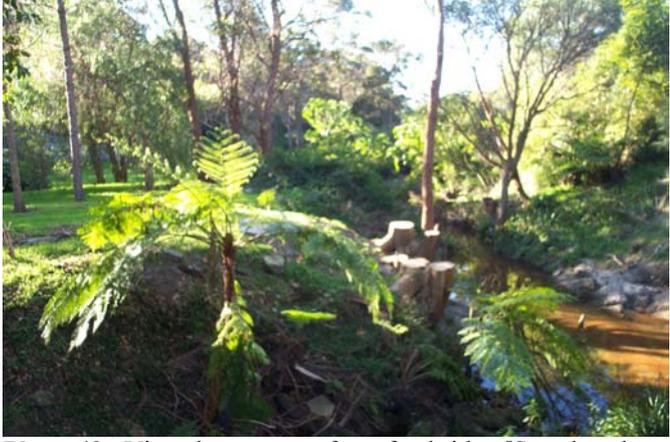
<p><b>Photo 49</b> View downstream from footbridge [See also photo 47]. Ref #0089</p>	<p><b>ATD 2.267 km</b></p> <p>Recently lopped tree on left bank.</p> <p>Banks are stable.</p>	<p>Management Priority <b>LOW</b></p> <p>Monitor only at this stage. Use rock boulders to stabilise bank if scouring occurs.</p> <p>Staged clearing of weed species. Technique 2.</p>

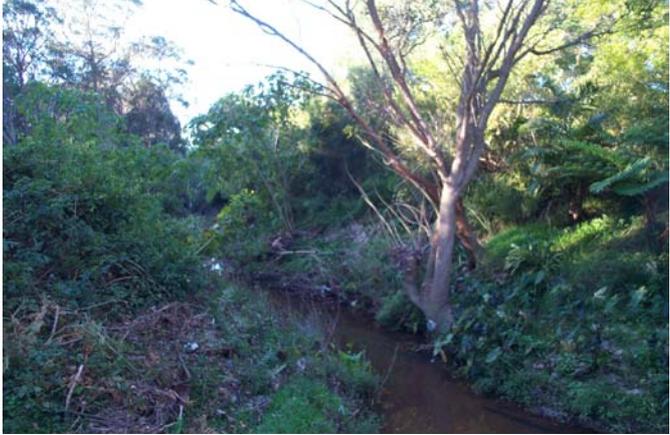
<p><b>ATD 2.320 km</b></p>	<p>Management Priority <b>LOW</b></p>
<p><b>Photo 55</b> View downstream. Ref #0096</p>	<p>Silt fence at top of right bank regeneration /weeding has occurred at top of bank. Broken concrete litters the bank. Right bank is steep and eroding over about 5m. Vegetated attached sandy bar on left bank.</p>	<p>Staged clearing of weed species. Some woody vegetation that has become stabilised is deflecting flows onto the banks and should be thinned/removed in a planned way. Technique 2.</p>

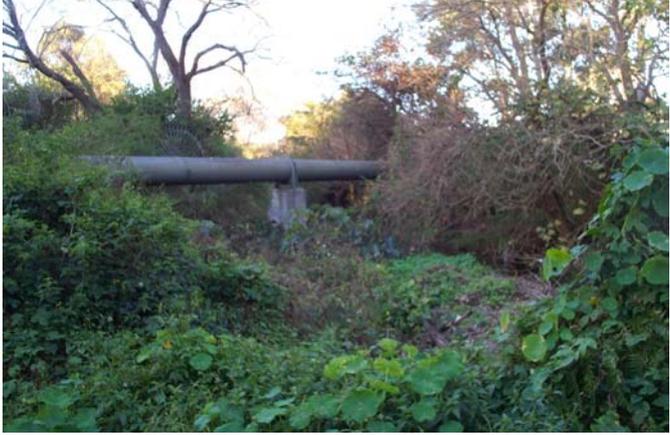
<p><b>ATD km</b></p>	<p>Management Priority <b>LOW</b></p>
<p><b>Photo 56</b> View downstream to pipeline crossing. Ref #0097</p>	<p>Vegetated but unstable sandy bar attached to left bank includes back channel next to left bank.</p>	<p>Staged clearing of weed species. Stabilise silt deposits in creek bed where they are not unduly obstructing flow leading to an unacceptable flood risk. Technique 2.</p>

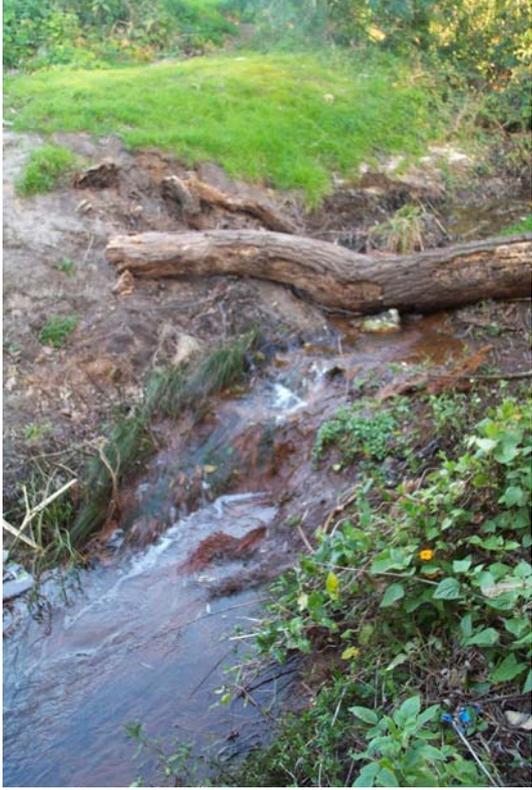
<p><b>ATD <math>\approx</math> 2.555km</b></p> <p>Drop in creek bed is likely to migrate upstream and should be stabilised.</p>	<p>Management Priority: <b>HIGH</b></p> <p>Employ Technique 2.</p>

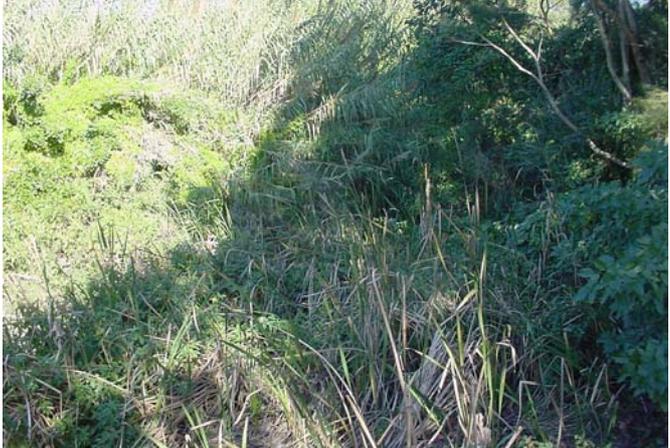
<p><b>ATD 2.75km</b></p> <p>Failure to maintain sufficient capacity in the creek channel will lead to further sedimentation and ultimately a widening manifested as bank erosion.</p>	<p>Management Priority: <b>HIGH</b></p> <p>Employ Technique 9 [Dredging] together with staged weed removal.</p>

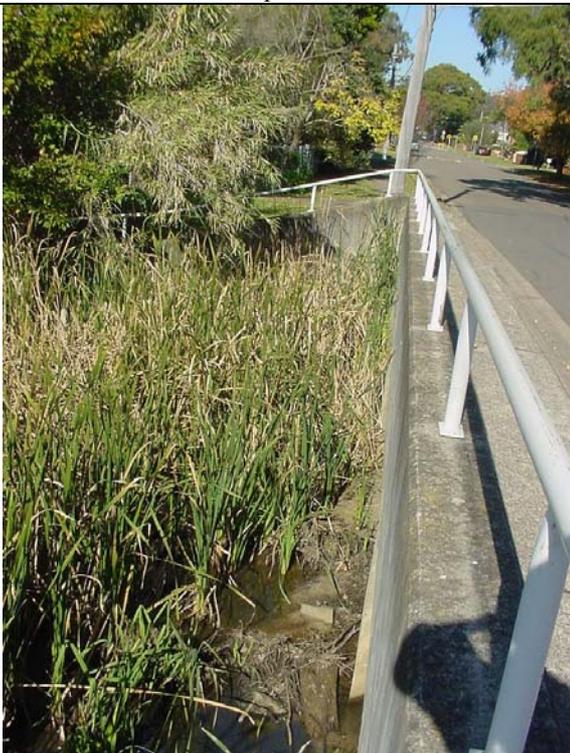
**Photo 68** Dense vegetation in creek bed downstream of Carcoola Rd.

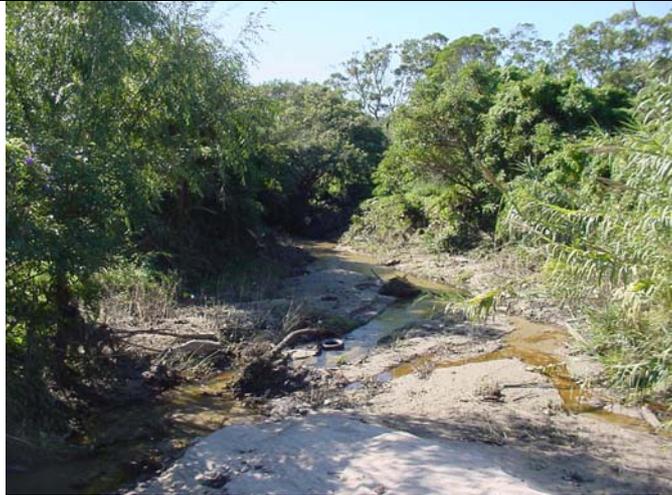
**Photo 70** Unconsolidated sediment deposits downstream of Carcoola Rd. Ref #41

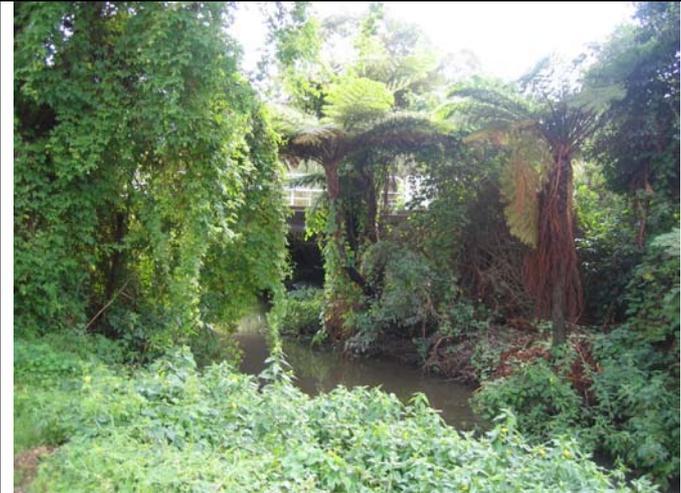
<p><b>ATD 3.31km</b></p> <p>Creek appears to be generally stable however weed removal and re-vegetation activities should be carefully planned and executed using an alternate strip removal technique [Technique 2B] to minimise the risk of locally high flood velocities and erosion.</p>	<p>Management Priority: <b>LOW</b> [monitor only]</p> <p>Staged clearing of weed species. Technique 2 as required.</p>

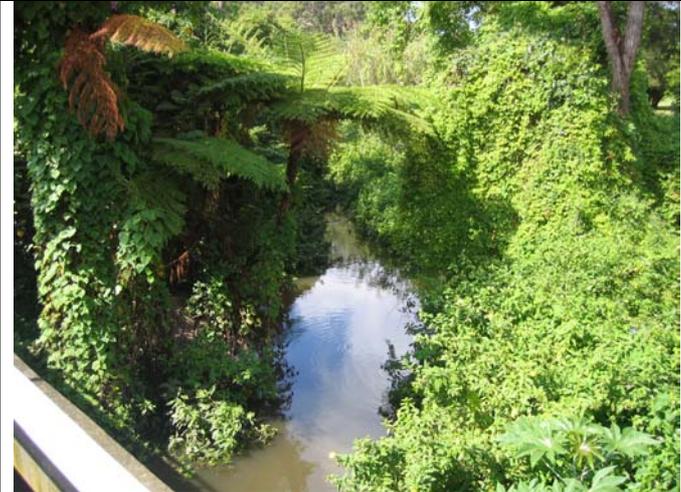
<p><b>ATD 3.44km</b></p> <p>Creek appears to be generally stable however weed removal and re-vegetation activities should be carefully planned and executed using an alternate strip removal technique [Technique 2B] to minimise the risk of locally high flood velocities and erosion.</p>	<p>Management Priority: <b>LOW</b> [monitor only]</p> <p>Staged clearing of weed species. Technique 2 as required.</p>

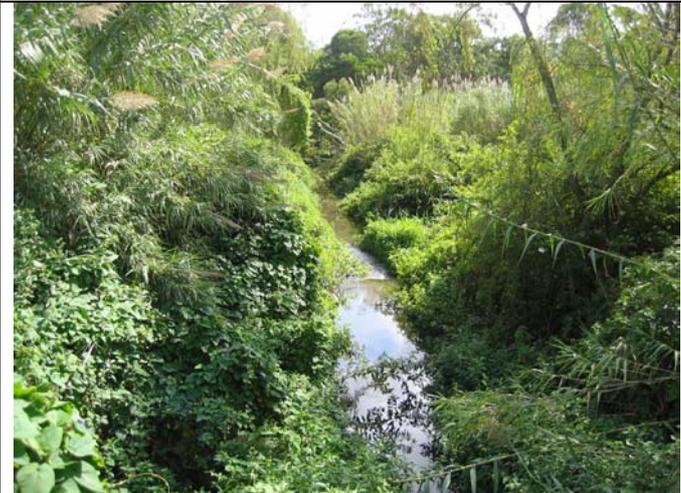
<p><b>ATD 3.47km</b></p> <p>Creek appears to be generally stable however weed removal and re-vegetation activities should be carefully planned and executed using an alternate strip removal technique [Technique 2B] to minimise the risk of locally high flood velocities and erosion.</p>	<p>Management Priority: <b>LOW</b> [monitor only]</p> <p>Staged clearing of weed species. Technique 2 as required.</p>

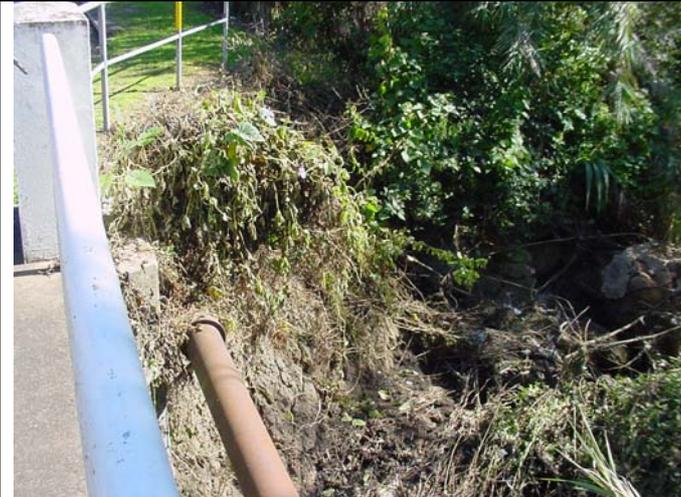
Immediately downstream of Toronto Avenue significant erosion was noted on the left bank, potentially undermining the bridge foundations and an exposed pipeline. In general the creek downstream of Toronto Ave was stable with only minor weed proliferation.

<p><b>ATD 3.47km</b></p> <p>Site inspection was undertaken in May 2007 after heavy rainfall in April 2007. Erosion was noted on the left bank around the footings of the Toronto Ave bridge.</p>	<p>Management Priority: <b>HIGH</b></p> <p>Employ Technique 7 [Rock Rip Rap] or Technique 8 [Gabions] to protect bridge foundations, infrastructure and services.</p>

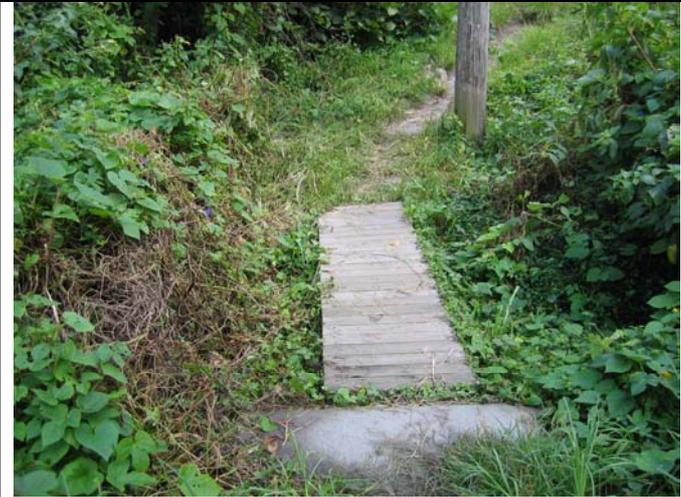
<p><b>ATD 3.5km</b></p> <p>Creek appears to be generally stable however weed removal and re-vegetation activities should be carefully planned and executed using an alternate strip removal technique [Technique 2B] to minimise the risk of locally high flood velocities and erosion.</p>	<p>Management Priority: <b>LOW</b> [monitor only]</p> <p>Staged clearing of weed species. Technique 2 as required.</p>

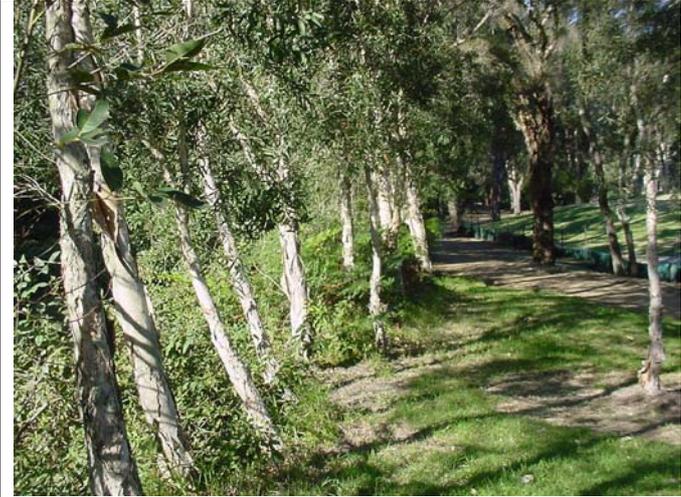
<p>Approx. ATD 3.65km</p> <p>Creek appears to be generally stable however weed removal and re-vegetation activities should be carefully planned and executed using an alternate strip removal technique [Technique 2B] to minimise the risk of locally high flood velocities and erosion.</p>	<p>Management Priority: <b>LOW</b> [monitor only]</p> <p>Staged clearing of weed species. Technique 2 as required.</p>

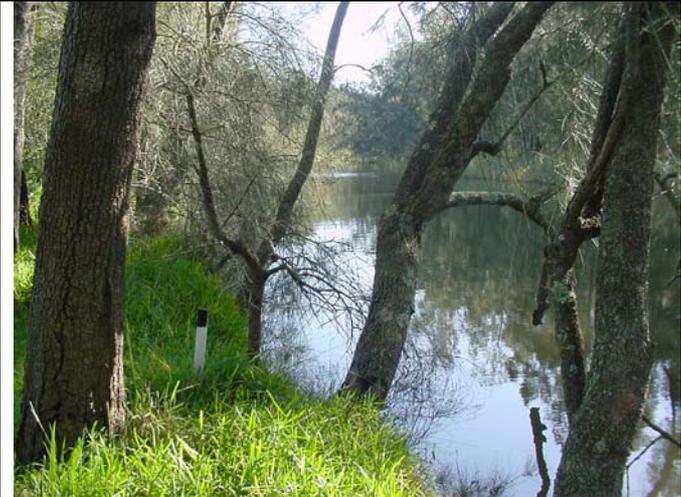
<p><b>ATD 4.20km</b></p> <p>Creek appears to be generally stable however weed removal and re-vegetation activities should be carefully planned and executed using an alternate strip removal technique [Technique 2B] to minimise the risk of locally high flood velocities and erosion.</p>	<p>Management Priority: <b>LOW</b> [monitor only]</p> <p>Monitor for weed species and remove as necessary.</p>
<p><b>Photo 83</b> View downstream from the left bank. Typical condition of the lagoon reach over the last few hundred metres. Ref #</p>	<p><b>ATD 4.39km</b></p> <p>Creek appears to be generally stable however weed removal and re-vegetation activities should be carefully planned and executed using an alternate strip removal technique [Technique 2B] to minimise the risk of locally high flood velocities and erosion.</p>	<p>Management Priority: <b>LOW</b> [monitor only]</p> <p>Monitor for weed species and remove as necessary.</p>
