# **SOUTH CREEK BANK MANAGEMENT PLAN**

**Report Prepared for**  
Warringah Council

4 February 2008  
LJ2434/R2381v3

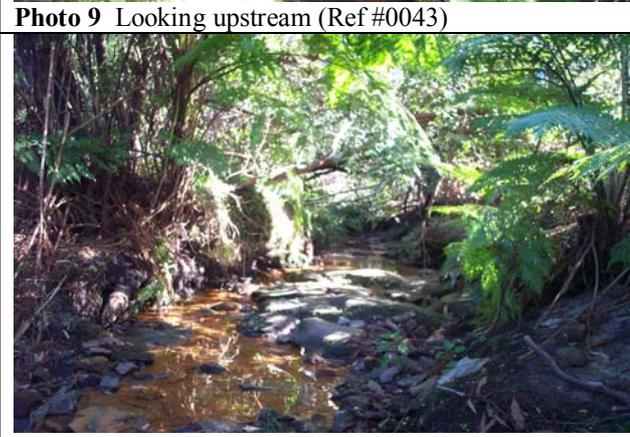
<p><b>ATD 0.460 km</b> Adjacent to school. Low banks, exposed but appear reasonably stable.</p> <p>Scrub includes significant quantities of <i>Pittosporum undulatum</i>.</p>	<p>Management Priority <b>VERY LOW</b></p> <p>Monitor only for signs of bank instability every 1 to 2 years or after large flood.</p>

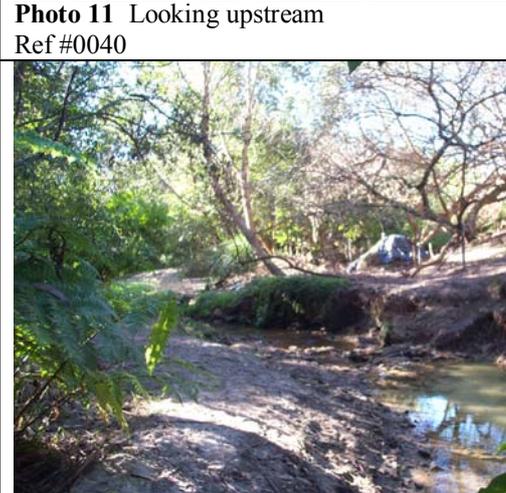
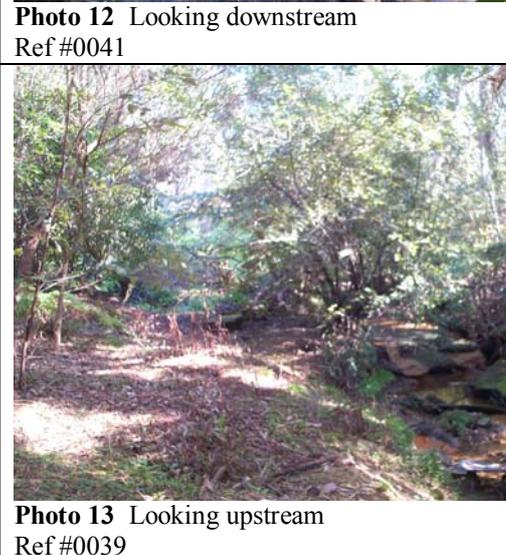
<p><b>ATD ≈ 0.510km</b> Cascade pool sequence bed rock outcrops Banks 1.5m and steep Good tree cover, minimal ground cover Pocket floodplain on right bank.</p>	<p>Management Priority: <b>Moderate</b></p> <p>Re-vegetate banks/Lower terrace using shade tolerant species. Techniques 1,2, 3.</p>

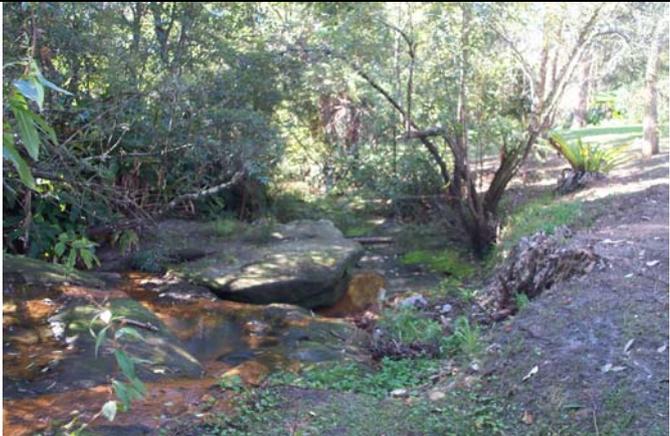
<p><b>Photo 16</b> Looking downstream Ref #0055</p>	<p><b>ATD ≈ 0.780km</b></p> <p>Between school and Willandra Road the creek is generally stable with sandy pockets and frequent bedrock outcrops and small waterfalls /cascades. Bare banks do not appear to be causing a significant problem.</p>	<p>Management Priority: <b>VERY LOW</b></p> <p>Monitor bare banks.</p> <p>Use toe rocks and battering with vegetation if banks show signs of active erosion.</p> <p>Technique ?</p>

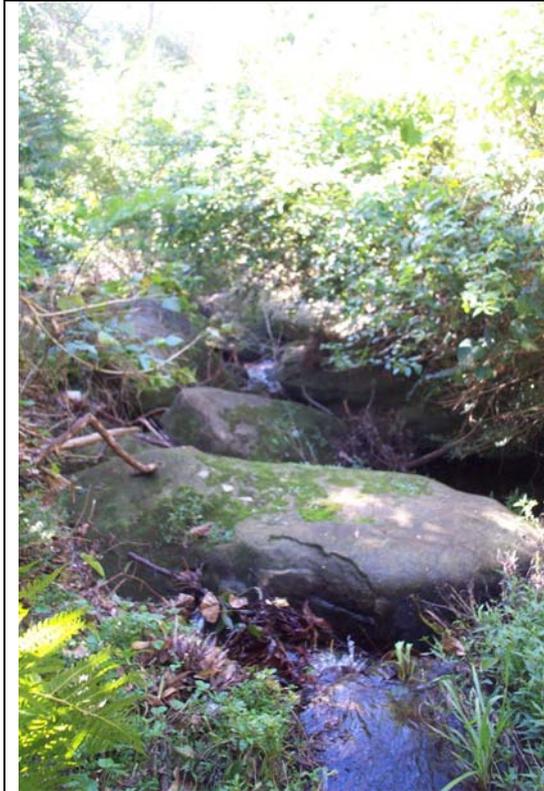
**Photo 17** Looking downstream  
Ref #0056

Area appeared stable when inspected [August 2005].

Management Priority:  
**Monitor** only.

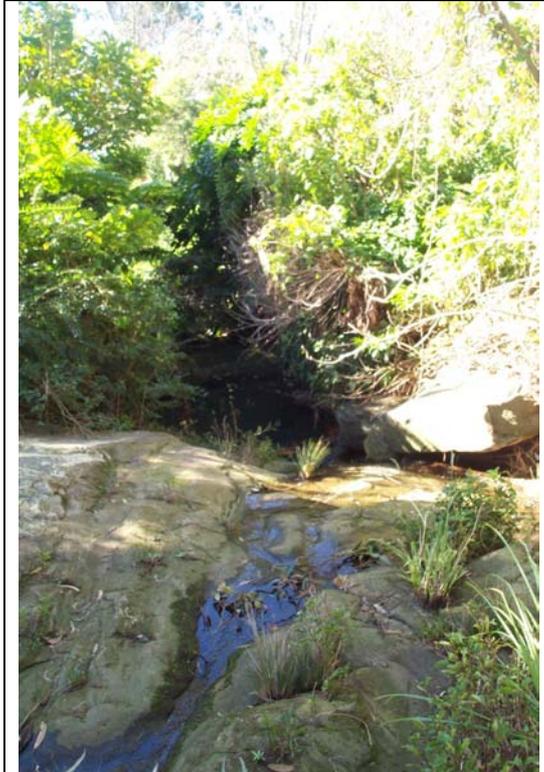
**Photo 18** Looking downstream  
Ref #0057

Area appeared stable when inspected [August 2005].

Management Priority:  
**Monitor** only

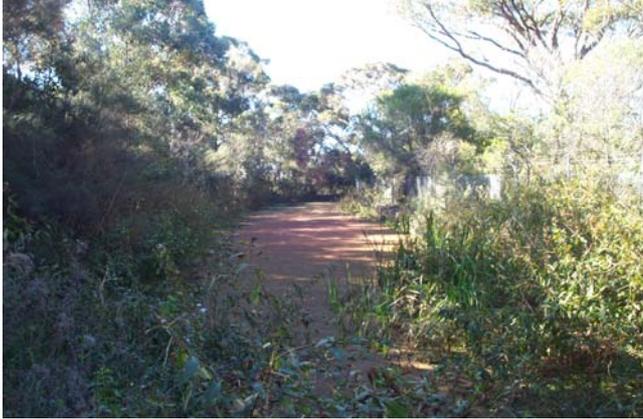
<p><b>ATD 1.130km</b></p> <p>Offline sediment trap / WQ pond on left bank downstream of McIntosh Rd.</p>	<p>Management Priority: <b>Monitor</b> only</p> <p>Monitor inlet and outlets for blockages.</p>

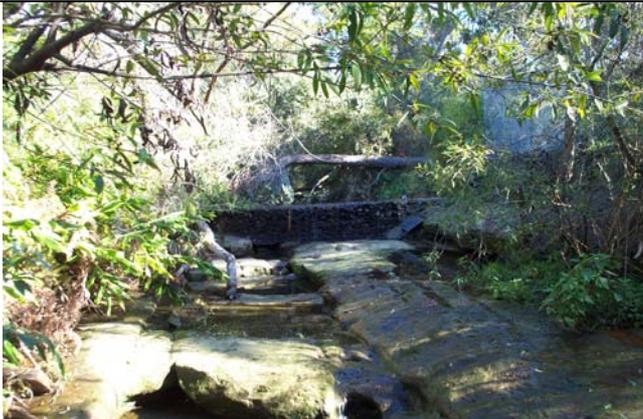
<p><b>ATD 1.130km</b></p> <p>Creek adjacent to WQ pond. Rock bed.</p> <p>Area appeared stable when inspected [August 2005].</p>	<p>Management Priority: <b>Monitor</b> only</p>

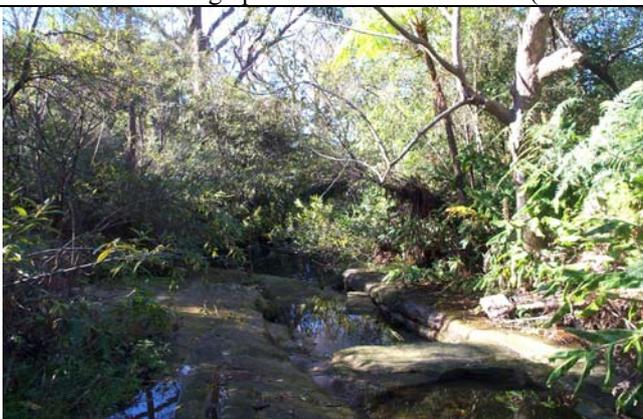
<p><b>ATD 1.160km</b></p> <p>Creek adjacent to WQ pond. Rock bed.</p> <p>Area appeared stable when inspected [August 2005].</p>	<p>Management Priority: <b>Monitor</b> only</p>

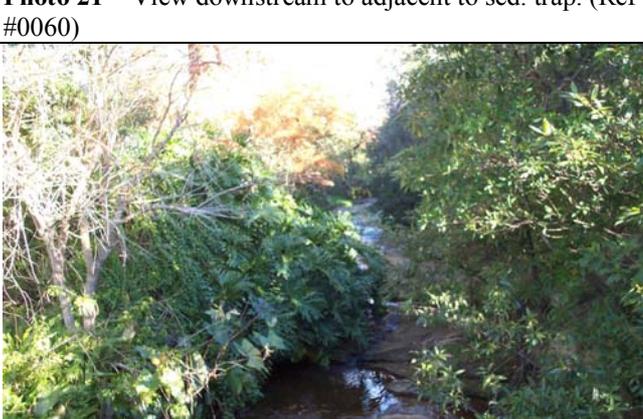
<p><b>ATD 1.170km</b></p> <p>Creek adjacent to WQ pond. Rock bed.</p>	<p>Management Priority: <b>Monitor</b> only</p>
<p><b>Photo 19</b> Looking downstream along sediment trap (Ref #0058)</p> <p><b>Photo 20</b> Looking upstream to diversion weir. (Ref #0059)</p> <p><b>Photo 21</b> View downstream to adjacent to sed. trap. (Ref #0060)</p> <p><b>Photo 22</b> View downstream beyond sediment trap. Ref #0061</p>

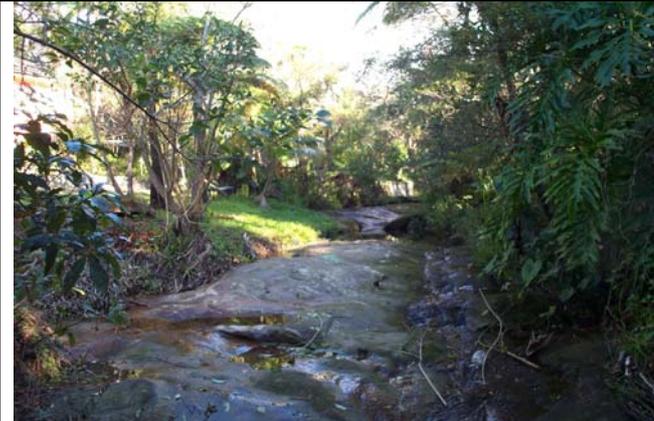
<p><b>ATD ≈1.220km</b></p> <p>Creek running over exposed bedrock. Low right bank and shallow soil showing some scour at the edges but not considered significant.</p>	<p>Management Priority: <b>Low</b></p> <p>Monitor only at this stage.</p> <p>Use techniques 2 or 4 or variations should work be required in future.</p>

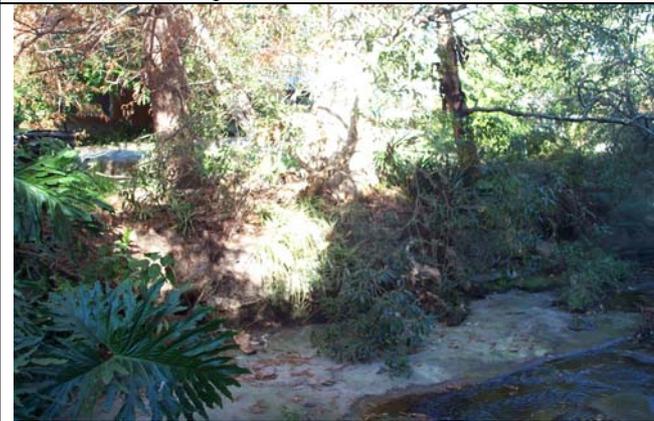
<p><b>ATD ≈1.230km</b></p> <p>Creek running over exposed bedrock. Some scour at toe of bank but not considered significant.</p>	<p>Management Priority: <b>LOW</b></p> <p>Monitor only.</p> <p>Use techniques 2 or 4 or variations should work be required in future.</p>

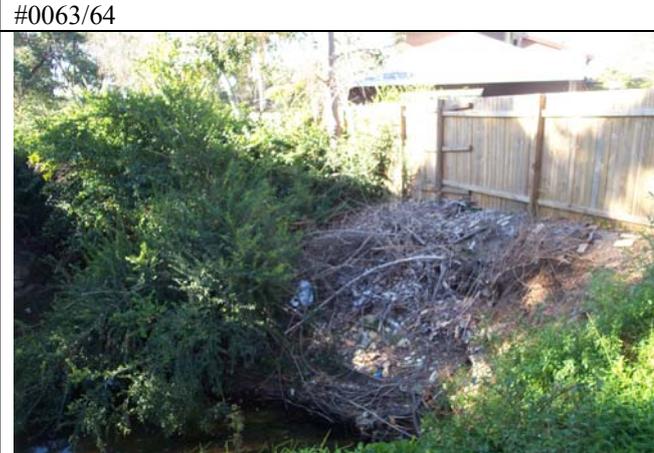
<p><b>ATD 1.268km</b></p> <p>Downstream side of Alkira Circuit. Unstable fill on right bank</p>	<p>Management Priority: <b>Moderate</b></p> <p>Use techniques 2 or 4 or variations to stabilise bank/fill.</p>

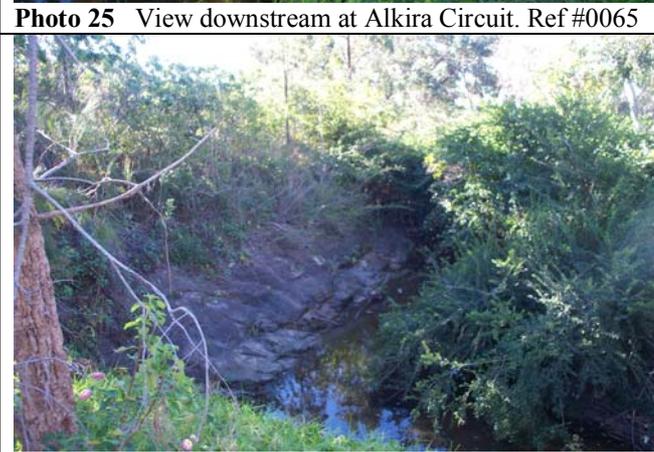
<p><b>ATD 1.268km</b></p> <p>Left bank exposed but appears stable.</p>	<p>Management Priority: <b>Monitor</b> only.</p>

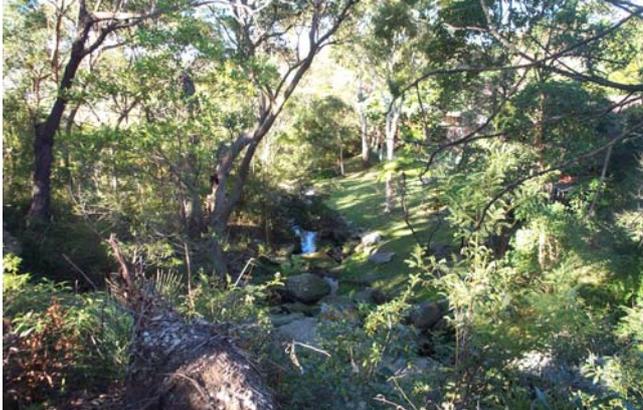
<p><b>Photo 27</b> View downstream from head of waterfall Ref #0067</p>	<p><b>ATD 1.310km</b></p> <p>Waterfall appears stable.</p>

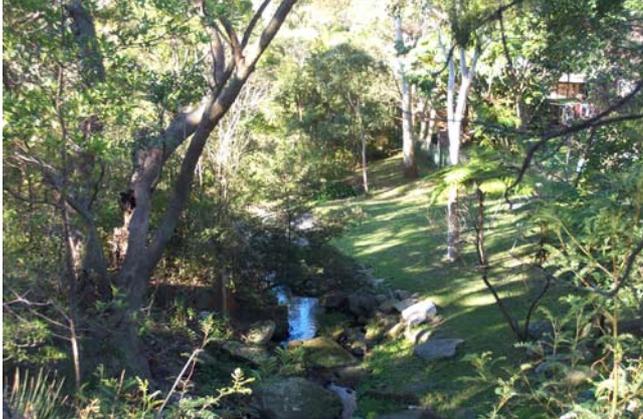
<p><b>Photo 28</b> View downstream at bottom of waterfall. Ref #0068</p>	<p><b>ATD 1.450km</b></p> <p>Shallow soil overlying bedrock forms creek banks and floodplains. Low exposed bank could erode in High floods but appears stable when inspected in August 2005.</p>	<p>Management Priority: <b>Monitor</b> only.</p> <p>Use techniques 2 or 4 or variations should work be required in future.</p>

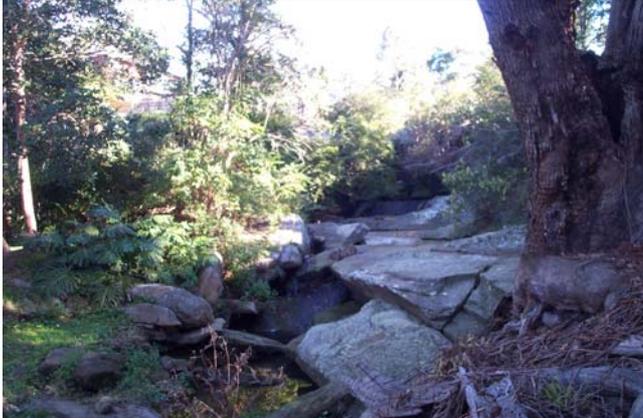
<p><b>Photo 29</b> View upstream towards waterfall. Ref #0069</p>	<p><b>ATD 1.460km</b></p> <p>Waterfall appears stable when inspected in august 2005.</p>	<p>Management Priority: <b>Monitor</b> only.</p>

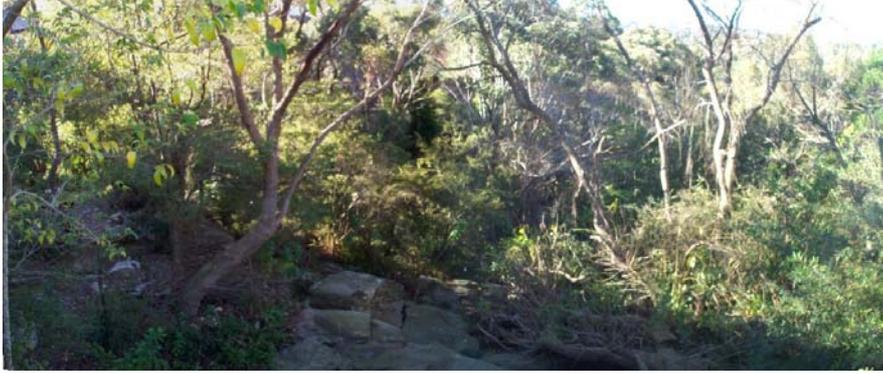
<p><b>Photo 30</b> View downstream Ref #0070 and #0071</p>	<p><b>ATD 1.500km</b></p> <p>Creek is confined by outcropping bedrock and is considered stable.</p>	<p>Management Priority: <b>Monitor</b> only for unstable debris that may wash downstream and block culverts.</p>

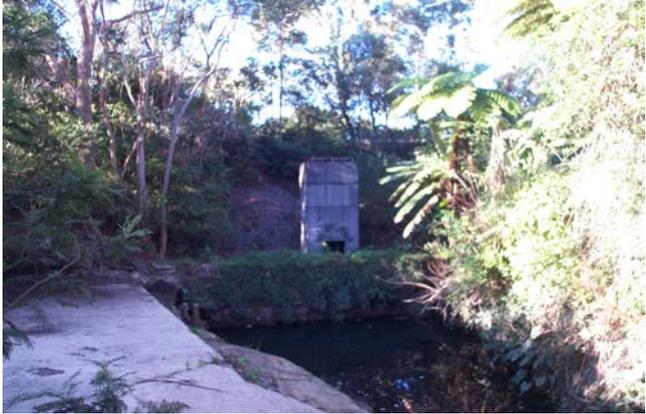
<p><b>Photo 32</b> Retarding basin outlet tower at McIntosh Road. Ref #0073</p>	<p><b>ATD 1.056 km</b></p> <p>Difficult to assess bank stability due to thick vegetation.</p>	<p><b>Priority: VERY LOW</b></p> <p>Monitor only for debris that may wash into outlet tower and excessive sediment deposits.</p>

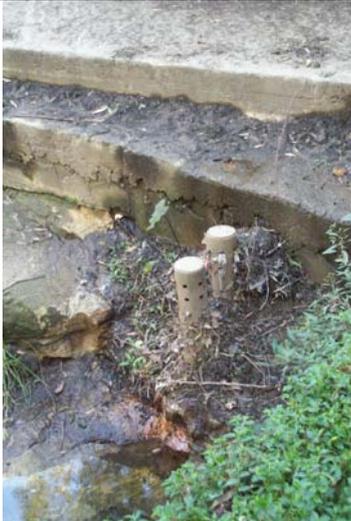
<p><b>Photo 33</b> Retarding basin sed. basin outlet Ref #0074</p>	<p><b>ATD 1.056 km</b></p> <p>Sediment trap outlet within retarding basin.</p>	<p><b>Priority: VERY LOW</b></p> <p>Monitor only for debris and sediment that may block outlets.</p>

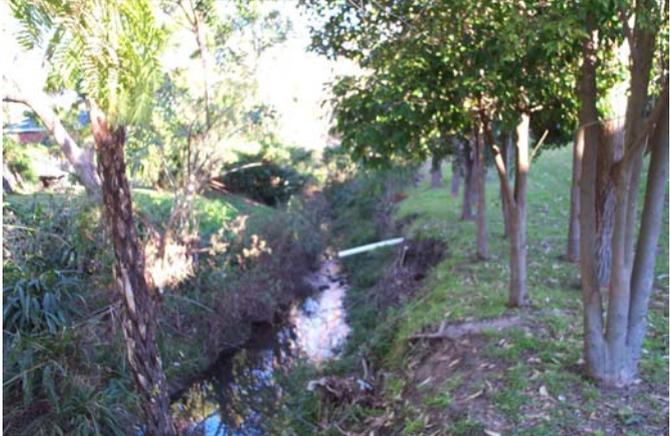
<p><b>Photo 34</b> View upstream behind Willandra Village Ref #0075</p>	<p><b>ATD 1.890km</b></p> <p>Incised alluvial creek. Left bank is actively retreating towards trees located between 0.5 and 1.5m from top of bank. Right bank appears to be stable.</p>	<p>Management Priority <b>HIGH</b></p> <p>Refer beLow</p>

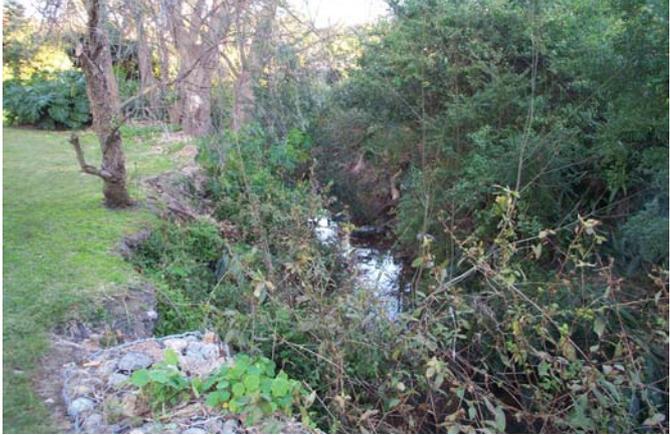
<p>Gabion retaining wall.</p>	
<p><b>Photo 42</b> View upstream from gabion retaining wall. Ref #0083</p>	<p><b>ATD 2.206 km</b></p>	<p>Management Priority <b>LOW</b></p>

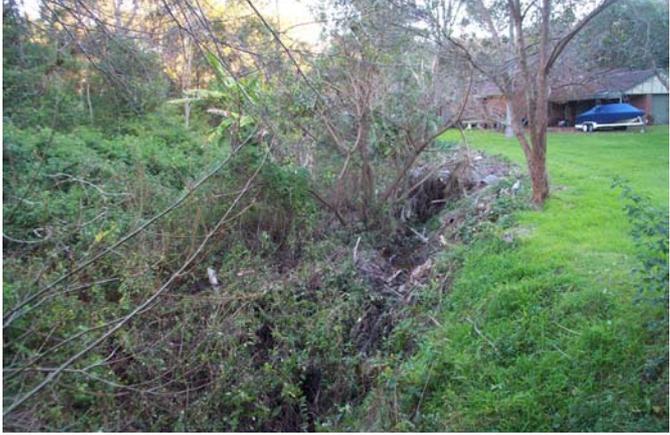
<p>Typical of reach where area characterised by weed species and patches of exposed bank.</p>	<p>Staged clearing of weed species. Technique 2.</p>
<p><b>Photo 44</b> View downstream Ref #0085</p>

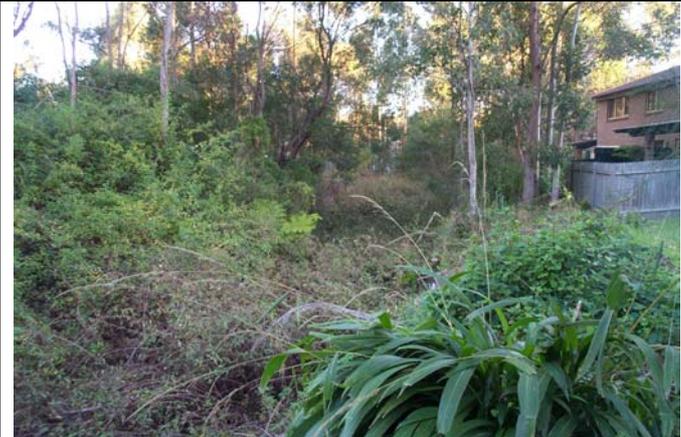
<p><b>ATD 2.225km</b></p> <p>View from 30m upstream of footbridge at ATD 2.267 km.</p> <p>Steep untidy bank littered with garden refuse.</p>	<p>Management Priority <b>MODERATE</b></p> <p>Staged clearing of weed species. Technique 2.</p>

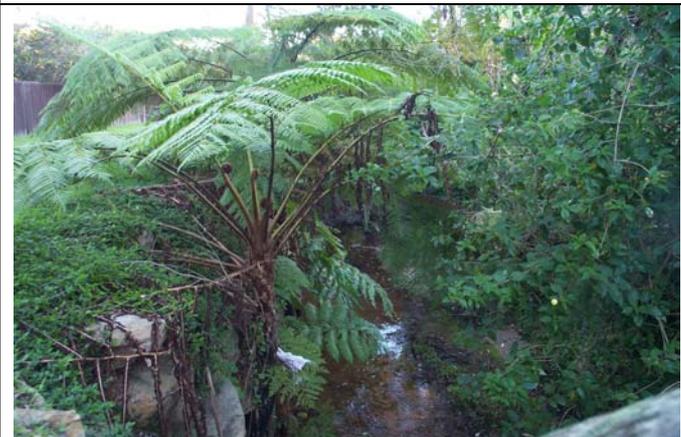
<p><b>ATD 2.266 km</b></p> <p>Prolific amount of lantana.</p>	<p>Management Priority <b>LOW</b></p> <p>Staged clearing of weed species. Technique 2.</p>

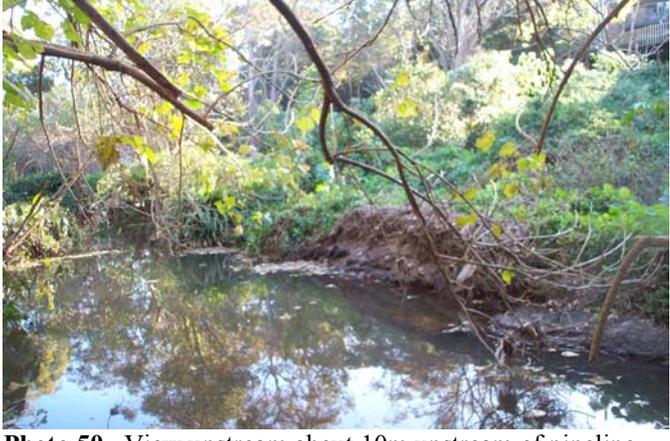
<p><b>Photo 50</b> View upstream about 10m upstream of pipeline. Ref #0090</p>	<p><b>ATD 2.32km</b></p> <p>5~6m eroding on opposite left bank. Low level sandy terrace with ineffective ground cover [Creeping Solomon].</p>	<p>Management Priority <b>LOW</b></p> <p>Staged clearing of weed species. Stabilise silt deposits in creek bed where they are not unduly obstructing flow leading to an unacceptable flood risk. Technique 2.</p>

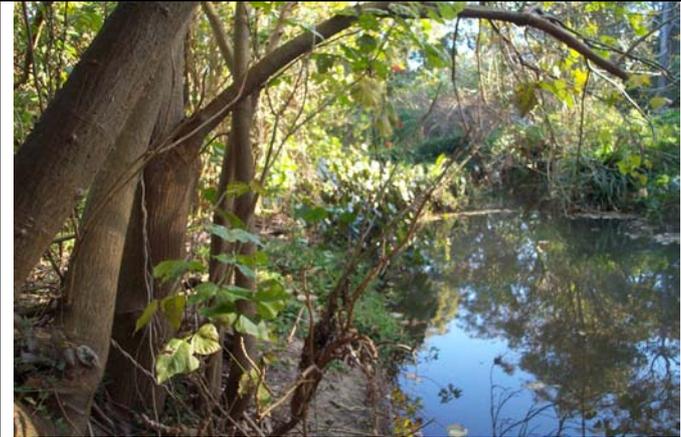
<p><b>ATD 2.32km</b></p> <p>Left bank – sandy pocket bench and Coral Tree.</p>	<p>Management Priority <b>LOW</b></p> <p>Staged clearing of weed species. Stabilise silt deposits in creek bed where they are not unduly obstructing flow leading to an unacceptable flood risk. Technique 2.</p>

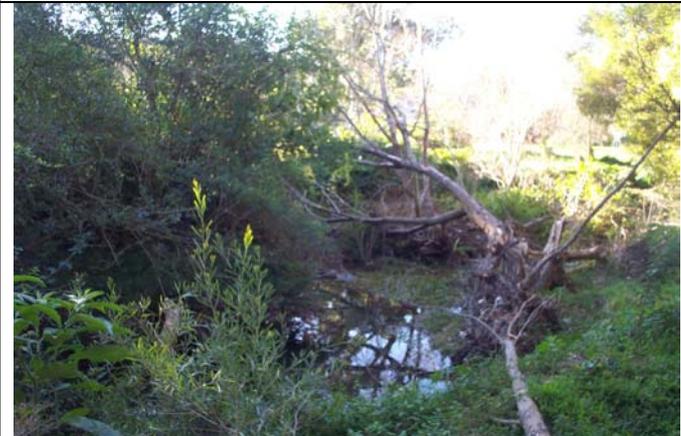
<p><b>ATD 2.510 km</b></p> <p>Weed infested sandy terrace on right bank. Fallen trees. Thick Lantana on left bank and unstable sandy deposits about 1m thick.</p>	<p>Management Priority <b>MODERATE</b></p> <p>Staged clearing of weed species. Some woody vegetation that has become stabilised is deflecting flows onto the banks and should be thinned/removed in a planned way. Technique 2.</p>

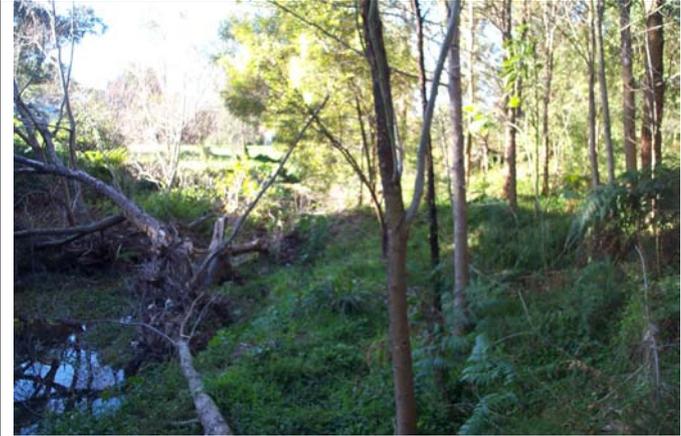
<p><b>ATD 2.520 km</b></p> <p>Open woodland type vegetation. Litter in creek includes car tyre. Cootamundra wattle.</p>	<p>Management Priority <b>MODERATE</b></p> <p>Staged clearing of weed species. Some woody vegetation that has become stabilised is deflecting flows onto the banks and should be thinned/removed in a planned way. Technique 2.</p>

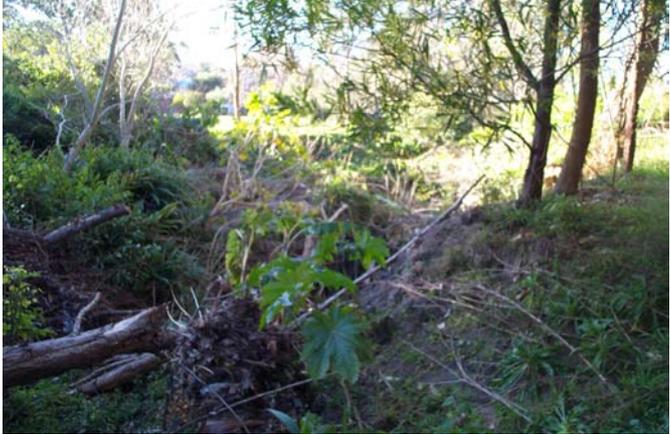
<p><b>ATD 2.520 km</b></p>	<p>Management Priority <b>MODERATE</b></p>
<p><b>Photo 54</b> View downstream from sandy terrace. Ref #0094</p>	<p>Fallen trees deflecting flow onto sandy bank. Lantana established on attached sandy bar [left bank].</p>	<p>Staged clearing of weed species. Some woody vegetation that has become stabilised is deflecting flows onto the banks and should be thinned/removed in a planned way. Technique 2.</p>

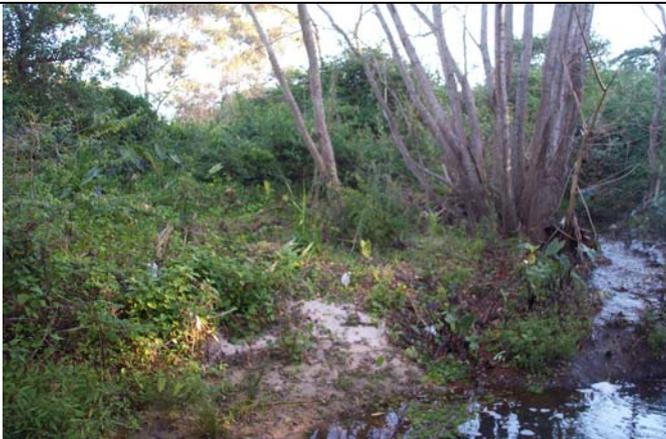
**Photo 59** View upstream – matches Photo 58  
Ref #0100

Management Priority  
**MONITOR**

Staged clearing of weed species. Stabilise silt deposits in creek bed where they are not unduly obstructing flow leading to an unacceptable flood risk. Technique 2.

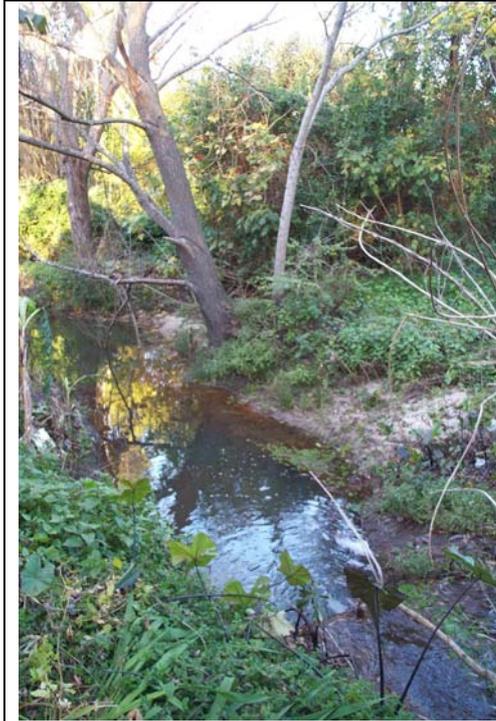
**Photo 60** 300mm High drop. View downstream.  
Ref #0101

Drop: **HIGH**  
Left bank: **URGENT**

Employ Technique 10 [drop] and Technique 2 [Bank].

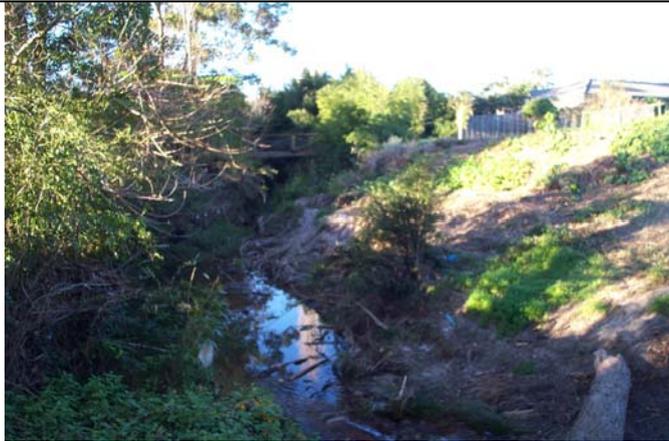
**Photo 61**  
Ref #0102

Left bank: **URGENT**

Employ Technique 2.

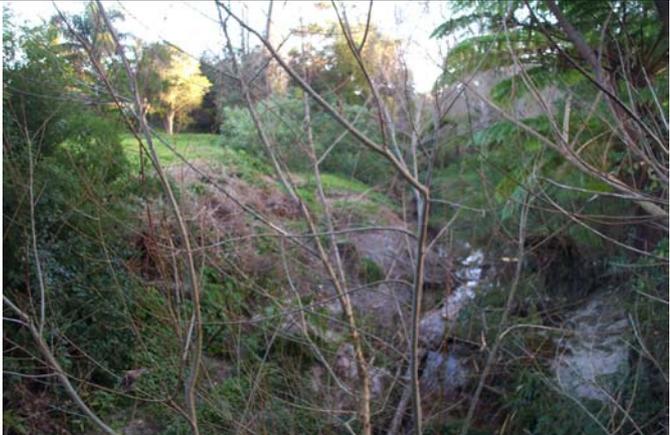
<p><b>ATD 2.590 km</b></p> <p>Exposed right bank after weed removal [August 2005]</p>	<p>Management Priority: <b>URGENT</b></p> <p>Employ Technique 2.</p>

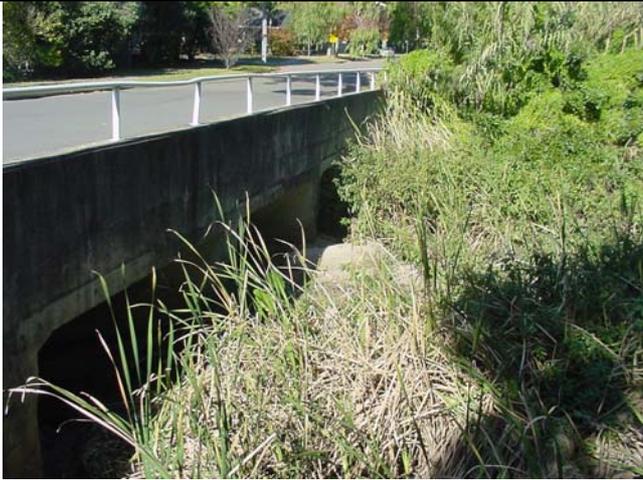
**Photo 66** View at upstream side of Carcoola rd bridge.

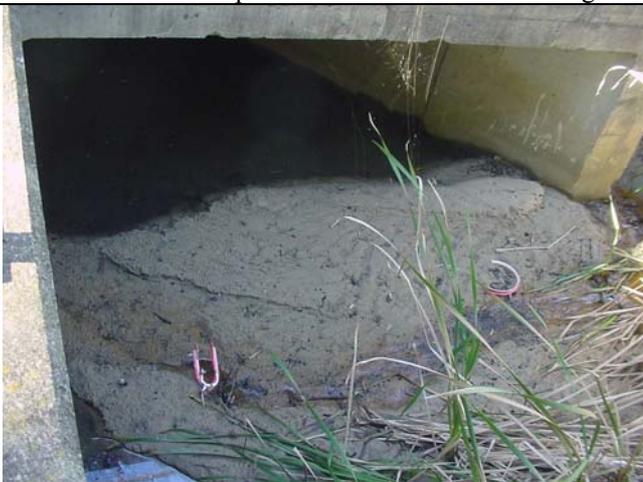
**Photo 67** Sediment deposit at Carcoola Road.

Failure to maintain sufficient capacity in the creek channel will lead to further sedimentation and ultimately a widening manifested as bank erosion.

Management Priority:  
**HIGH**

Employ Technique 9 [Dredging] together with staged weed removal.

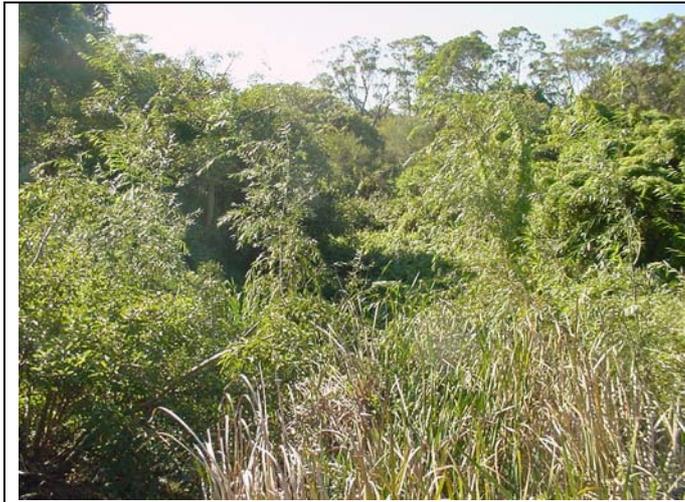
**Photo 69** View downstream of Carcoola Rd. showing dense vegetation in creek bed.

Failure to maintain sufficient capacity in the creek channel will lead to further sedimentation and ultimately a widening manifested as bank erosion.

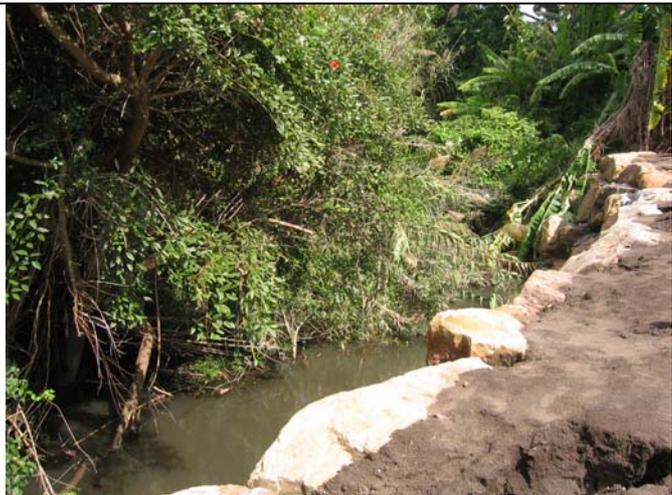
There is a need to monitor the toe of the rock wall to check for scour and possible destabilisation.

Management Priority:  
**MONITOR** for undercutting along toe of wall. Use rock rip is scouring becomes evident [Technique 7].

**Photo 71** Placed rock bank stabilisation at Grover Ave. Ref #2367

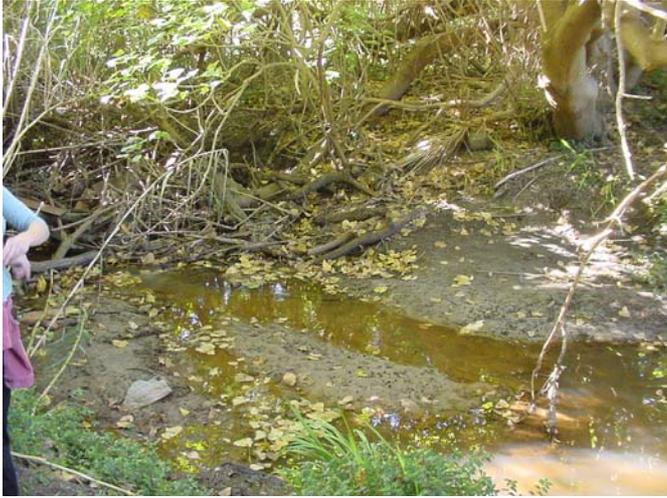
**Photo 72** Creek channel adjacent to natural sediment basin.  
Ref #31

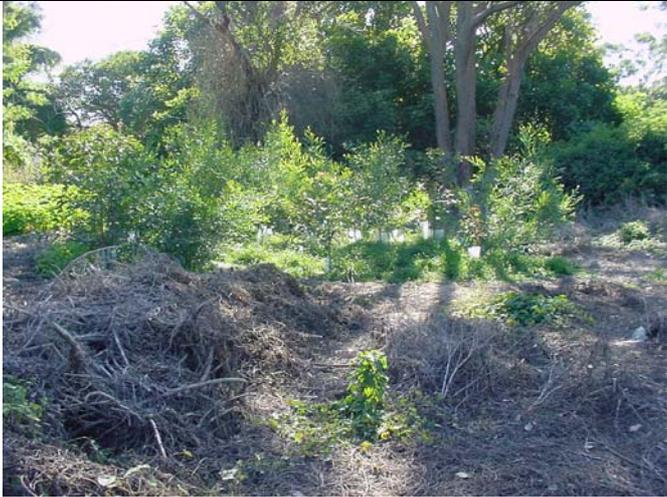
**Photo 73** Stabilised sediment deposits opposite St Matthews Farm reserve.  
Ref #35

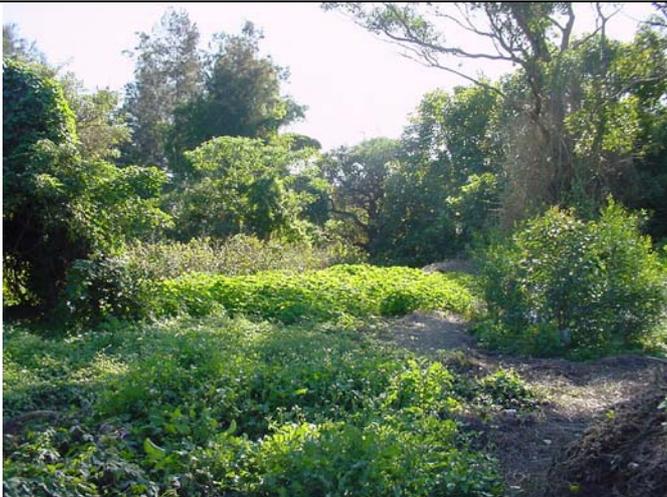
**Photo 74** Stabilised sediment deposits opposite St Matthews Farm reserve.  
Ref #37

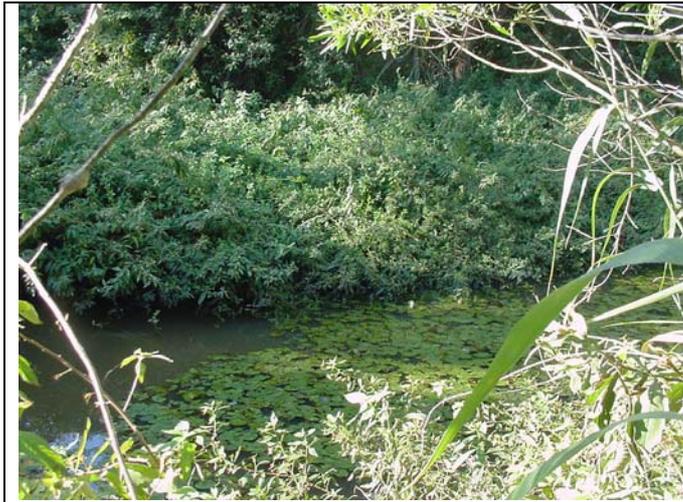
**Photo 80** Typical vegetation on the right bank opposite the golf course

**Approx. ATD 3.8km**  
 Creek appears to be generally stable however weed removal and re-vegetation activities should be carefully planned and executed using an alternate strip removal technique [Technique 2B] to minimise the risk of locally high flood velocities and erosion.

Management Priority:  
**LOW** [monitor only]  
 Staged clearing of weed species. Technique 2 as required.

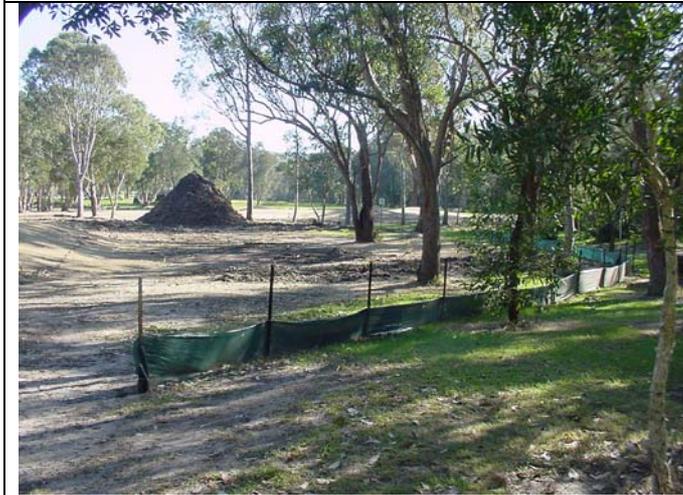
**Photo 81** Management practice at golf course.

Management Priority:  
**LOW** [monitor only]  
 Monitor for weed species and remove as necessary.

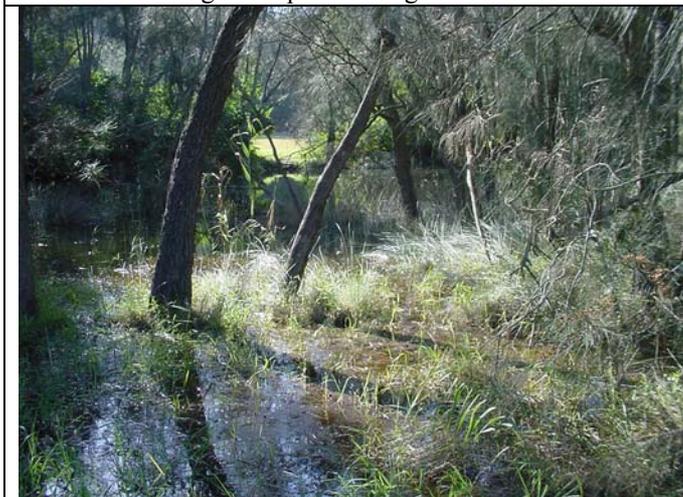
**Photo 82** Swampy edge of creek opposite golf course.

Management Priority:  
**LOW** [monitor only]  
 Monitor for weed species and remove as necessary.

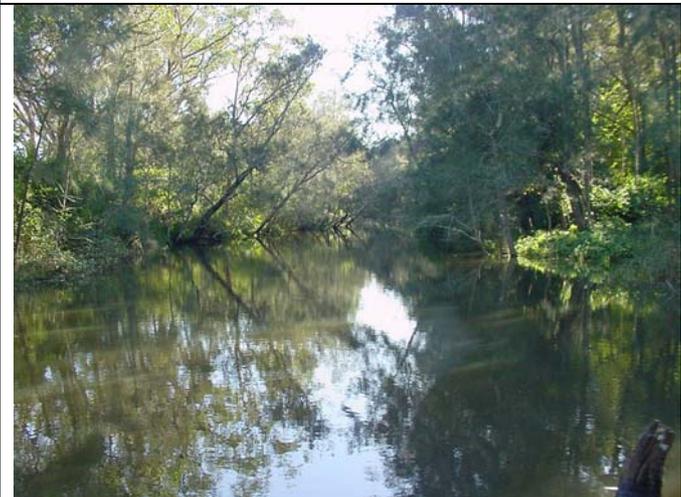
<p><b>ATD 4.20km</b></p> <p>Creek appears to be generally stable however weed removal and re-vegetation activities should be carefully planned and executed using an alternate strip removal technique [Technique 2B] to minimise the risk of locally high flood velocities and erosion.</p>	<p>Management Priority: <b>LOW</b> [monitor only]</p> <p>Monitor for weed species and remove as necessary.</p>
<p><b>Photo 83</b> View downstream from the left bank. Typical condition of the lagoon reach over the last few hundred metres. Ref #</p>	<p><b>ATD 4.39km</b></p> <p>Creek appears to be generally stable however weed removal and re-vegetation activities should be carefully planned and executed using an alternate strip removal technique [Technique 2B] to minimise the risk of locally high flood velocities and erosion.</p>	<p>Management Priority: <b>LOW</b> [monitor only]</p> <p>Monitor for weed species and remove as necessary.</p>

<p><b>Photo 84</b> View upstream from the left bank. Typical condition of the lagoon reach over the last few hundred metres. Ref #</p>
